Cazenovia College Redevelopment Study

Completed 2025

MRB
Group

Village of
Cazenovia, NY

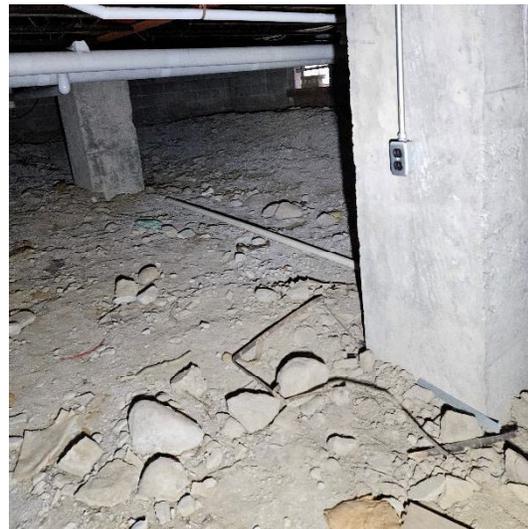
Dirt/stone at flooring conditions

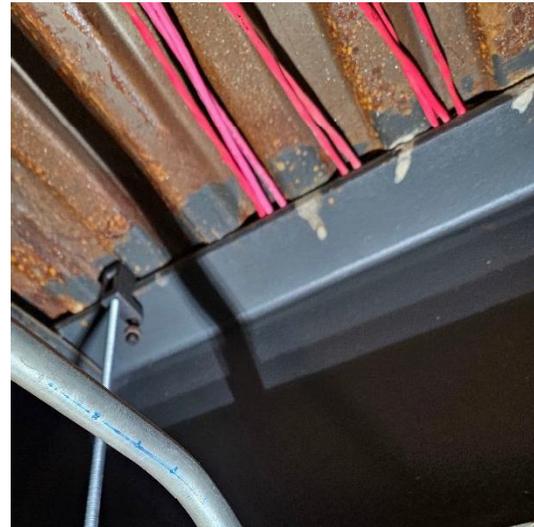
Surface corrosion on metal deck

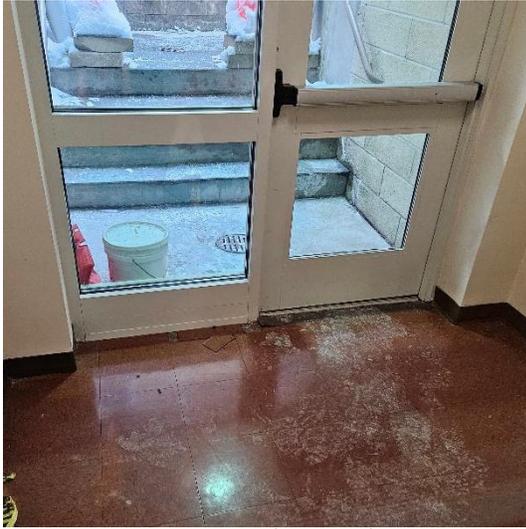
Damaged tile and signs of water infiltration at below grade egress

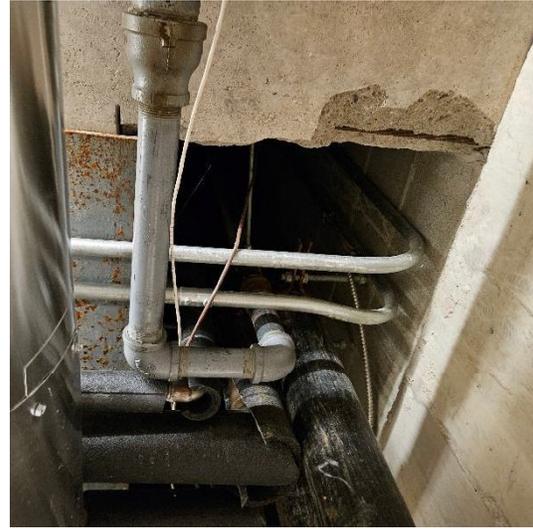
Exposed floor plank strand at basement mechanical room

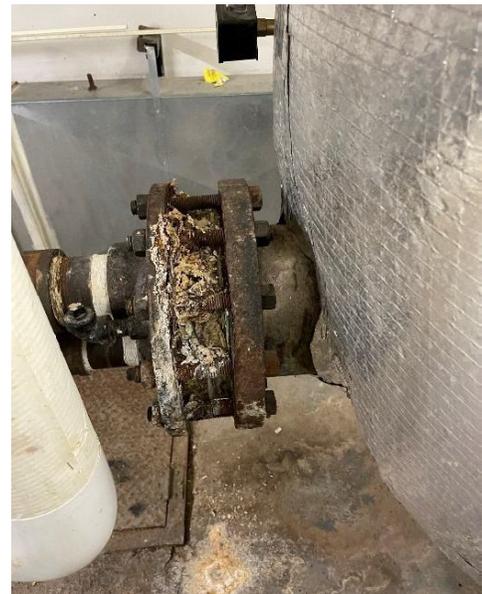
Flange corrosion

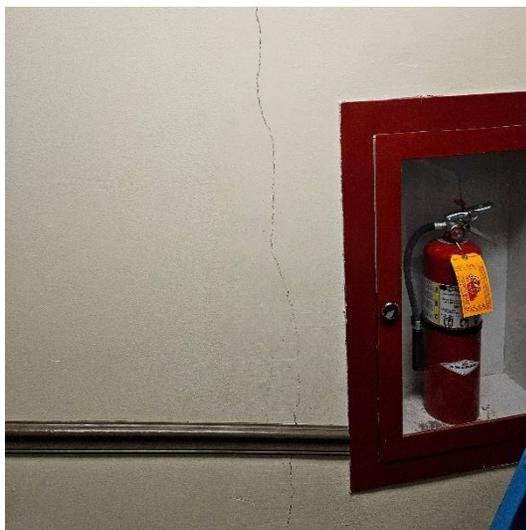
Cracking in 2nd floor wall finish

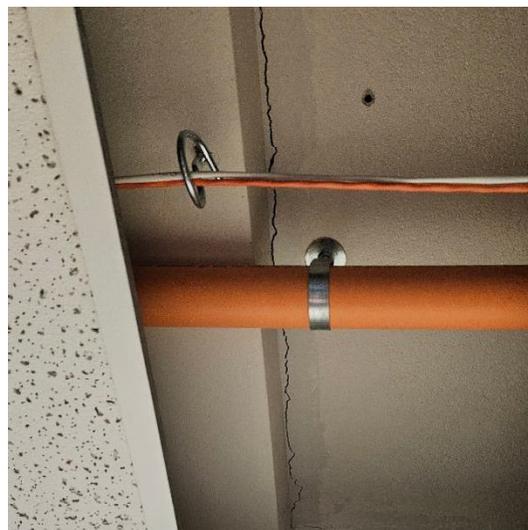
Cracking in 2nd floor ceiling finish

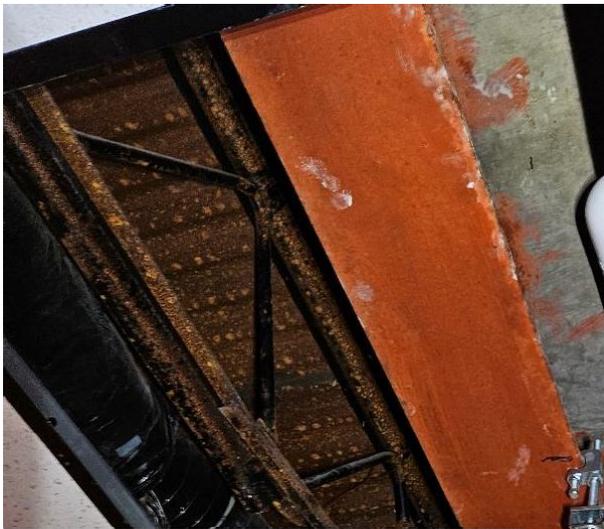
Extensive surface corrosion

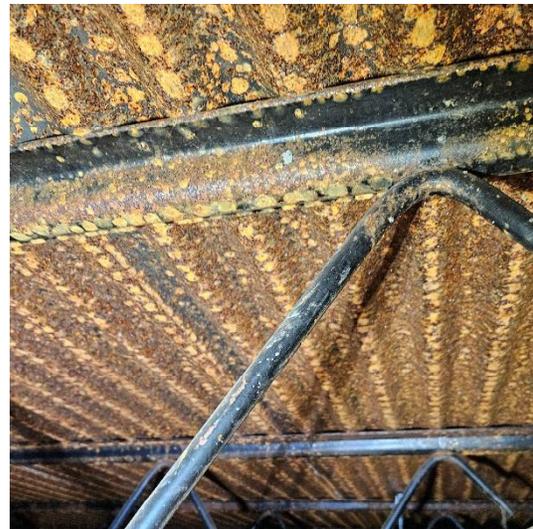
Extensive surface corrosion

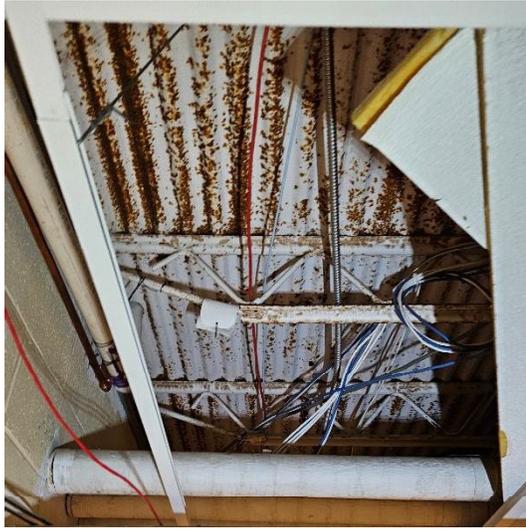
Surface corrosion on deck and joists

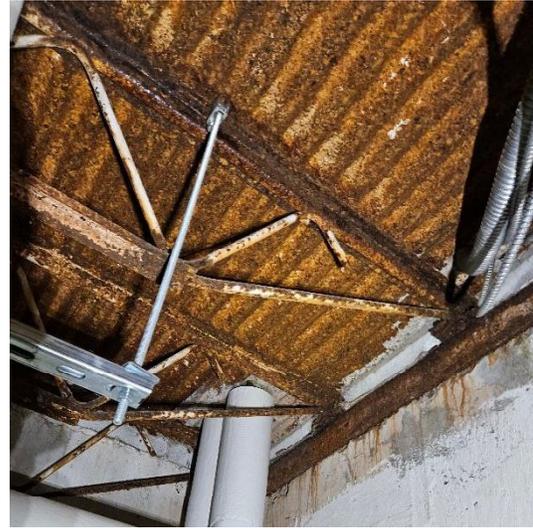
Extensive corrosion on deck and joists

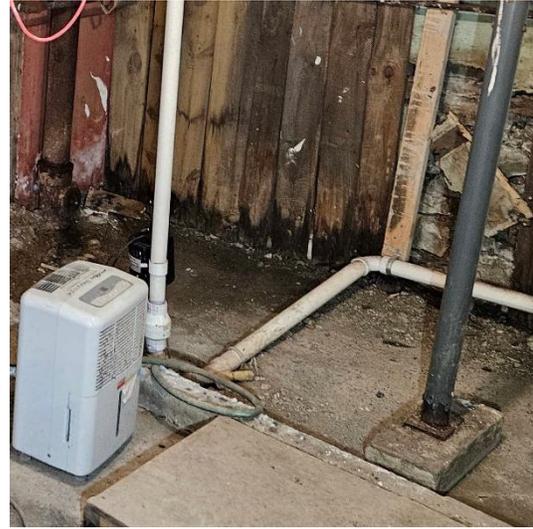
Water damage in basement

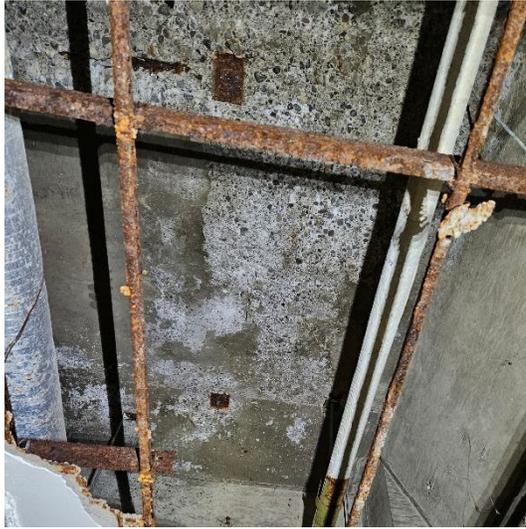
Concrete spalling & exposed reinforcing

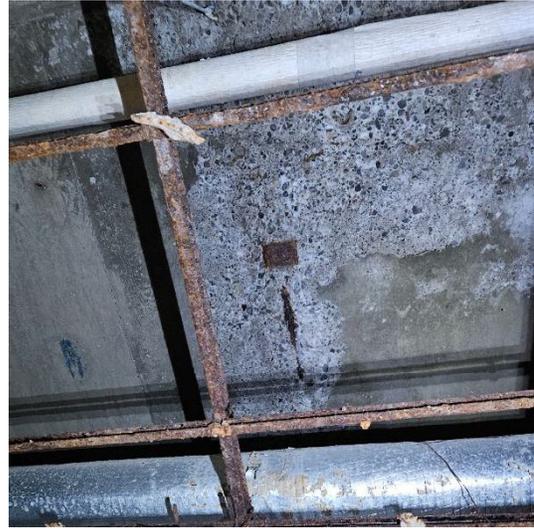
Concrete spalling & exposed reinforcing

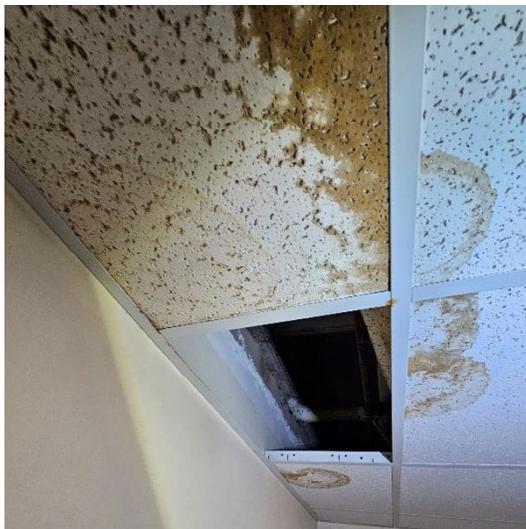
- Where the framing could be visually observed, no significant areas requiring repairs or replacement were found. The water-stained ceiling tiles were dry to the touch, but this area should be monitored for signs of water infiltration

Water stained ceiling tiles

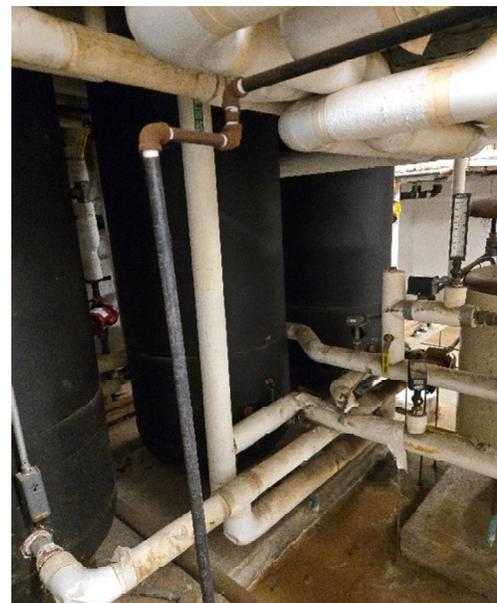
Partially abandoned domestic water system

While the domestic hot water heaters are at the end of their useful lives, they are serviceable. Recommend reviewing system for miscellaneous replacements while removing any of the abandoned in place storage tank system.

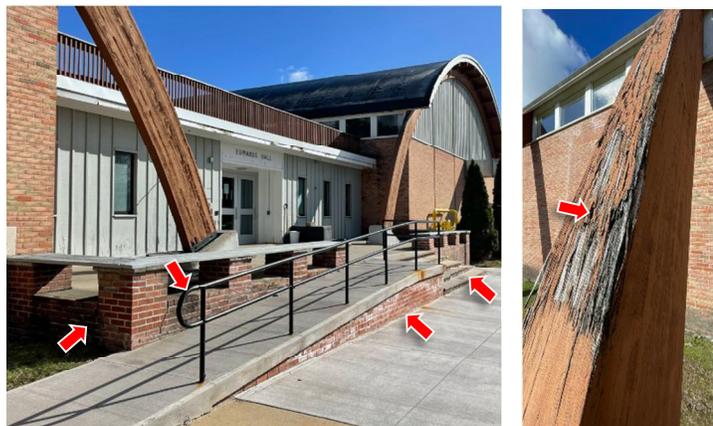
Deteriorated masonry at seat wall, ramp, and steps.

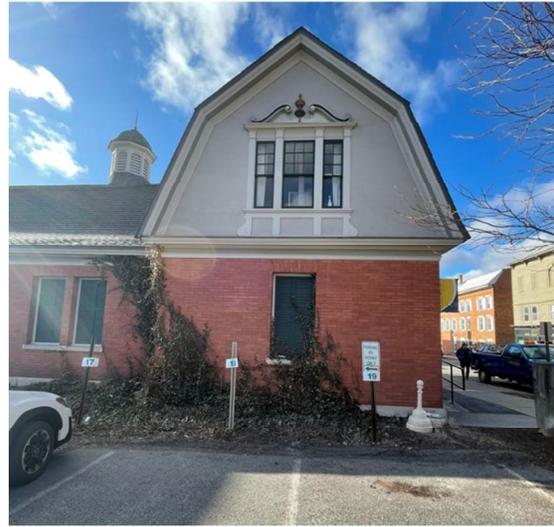
gambrel truss end & building Exterior ivy
