CAZENOVIA LAKEFRONT  
**DEVELOPMENT GUIDELINES**

Prepared By:  
Cazenovia Advisory Conservation Commission

December 2017

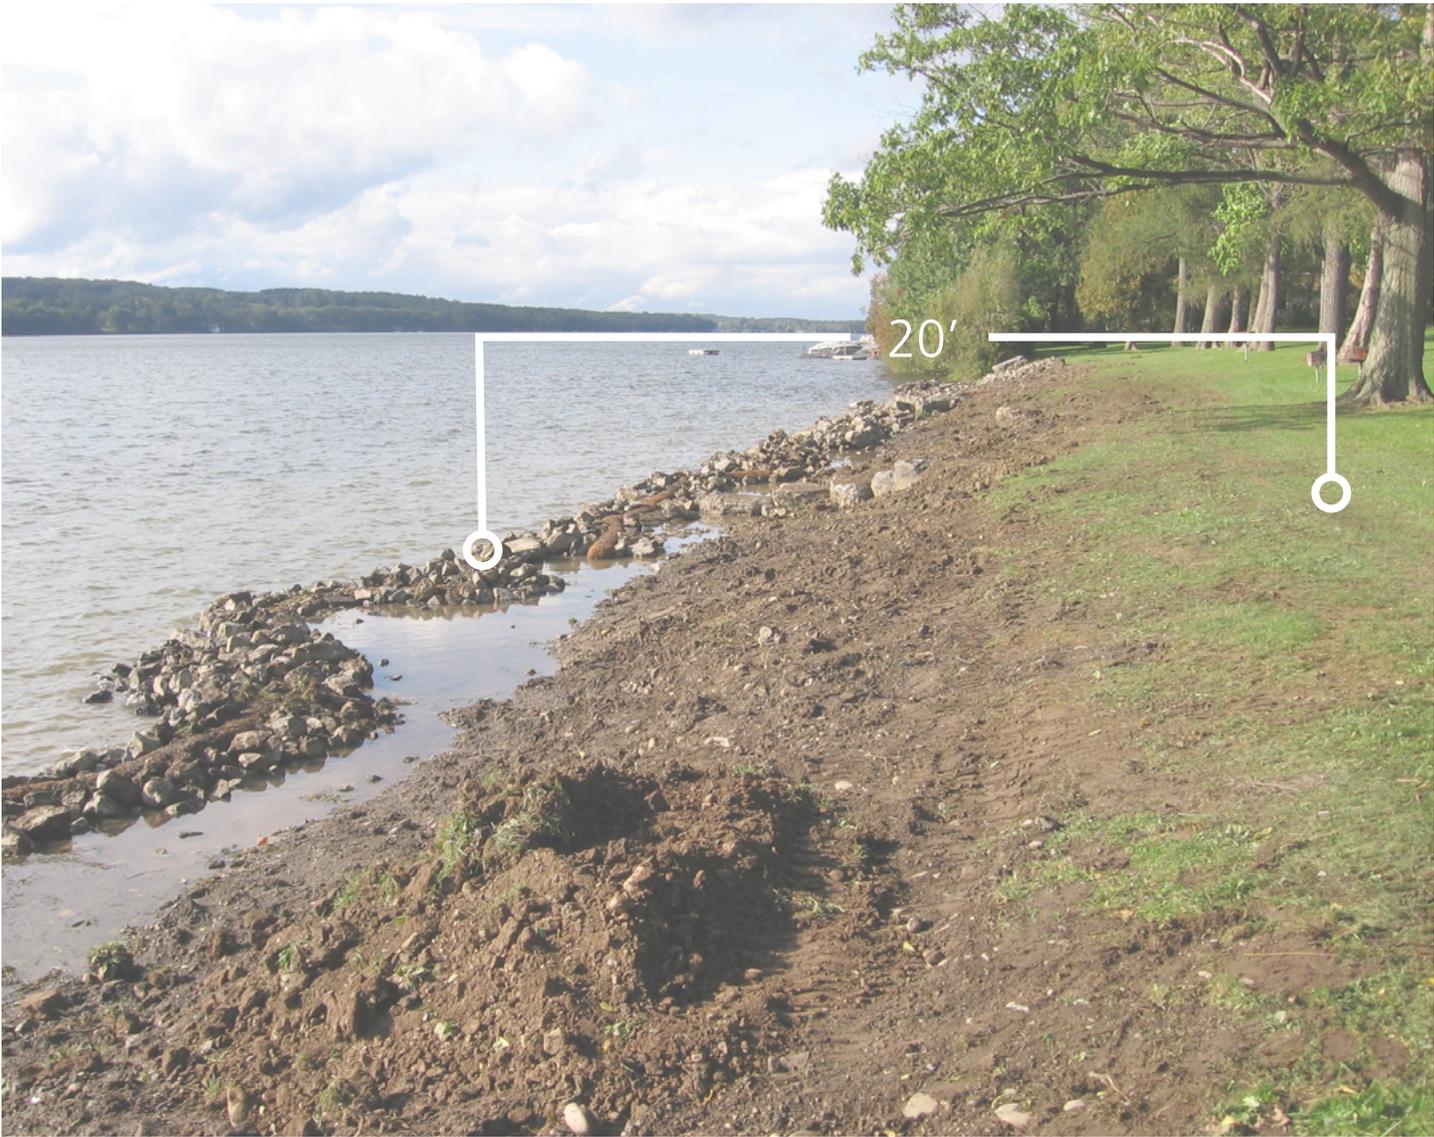
Figure 1.1 – Critical Environmental Area (CEA)

*Within this area impervious surfaces (walls, walks, patios, steps, etc.) greater than 5% are not allowed.*

Town of Cazenovia zoning regulations have established a 20 foot wide Critical Environmental Area (CEA) along the lakefront. Within this area, impervious surfaces (walls, walks, patios, steps, etc.) greater than 5% are not allowed. This leaves 95% of the shore front potentially available for the continuation or restoration of a natural or naturalistic waterfront. However, when areas surrounding the impervious landscape features are considered for residential use one can envision that an additional 20 to 25% of the CEA would be disturbed to some degree to re-establish lakefront features, integrate new structures or plantings into the site, and/or to create lake vistas.

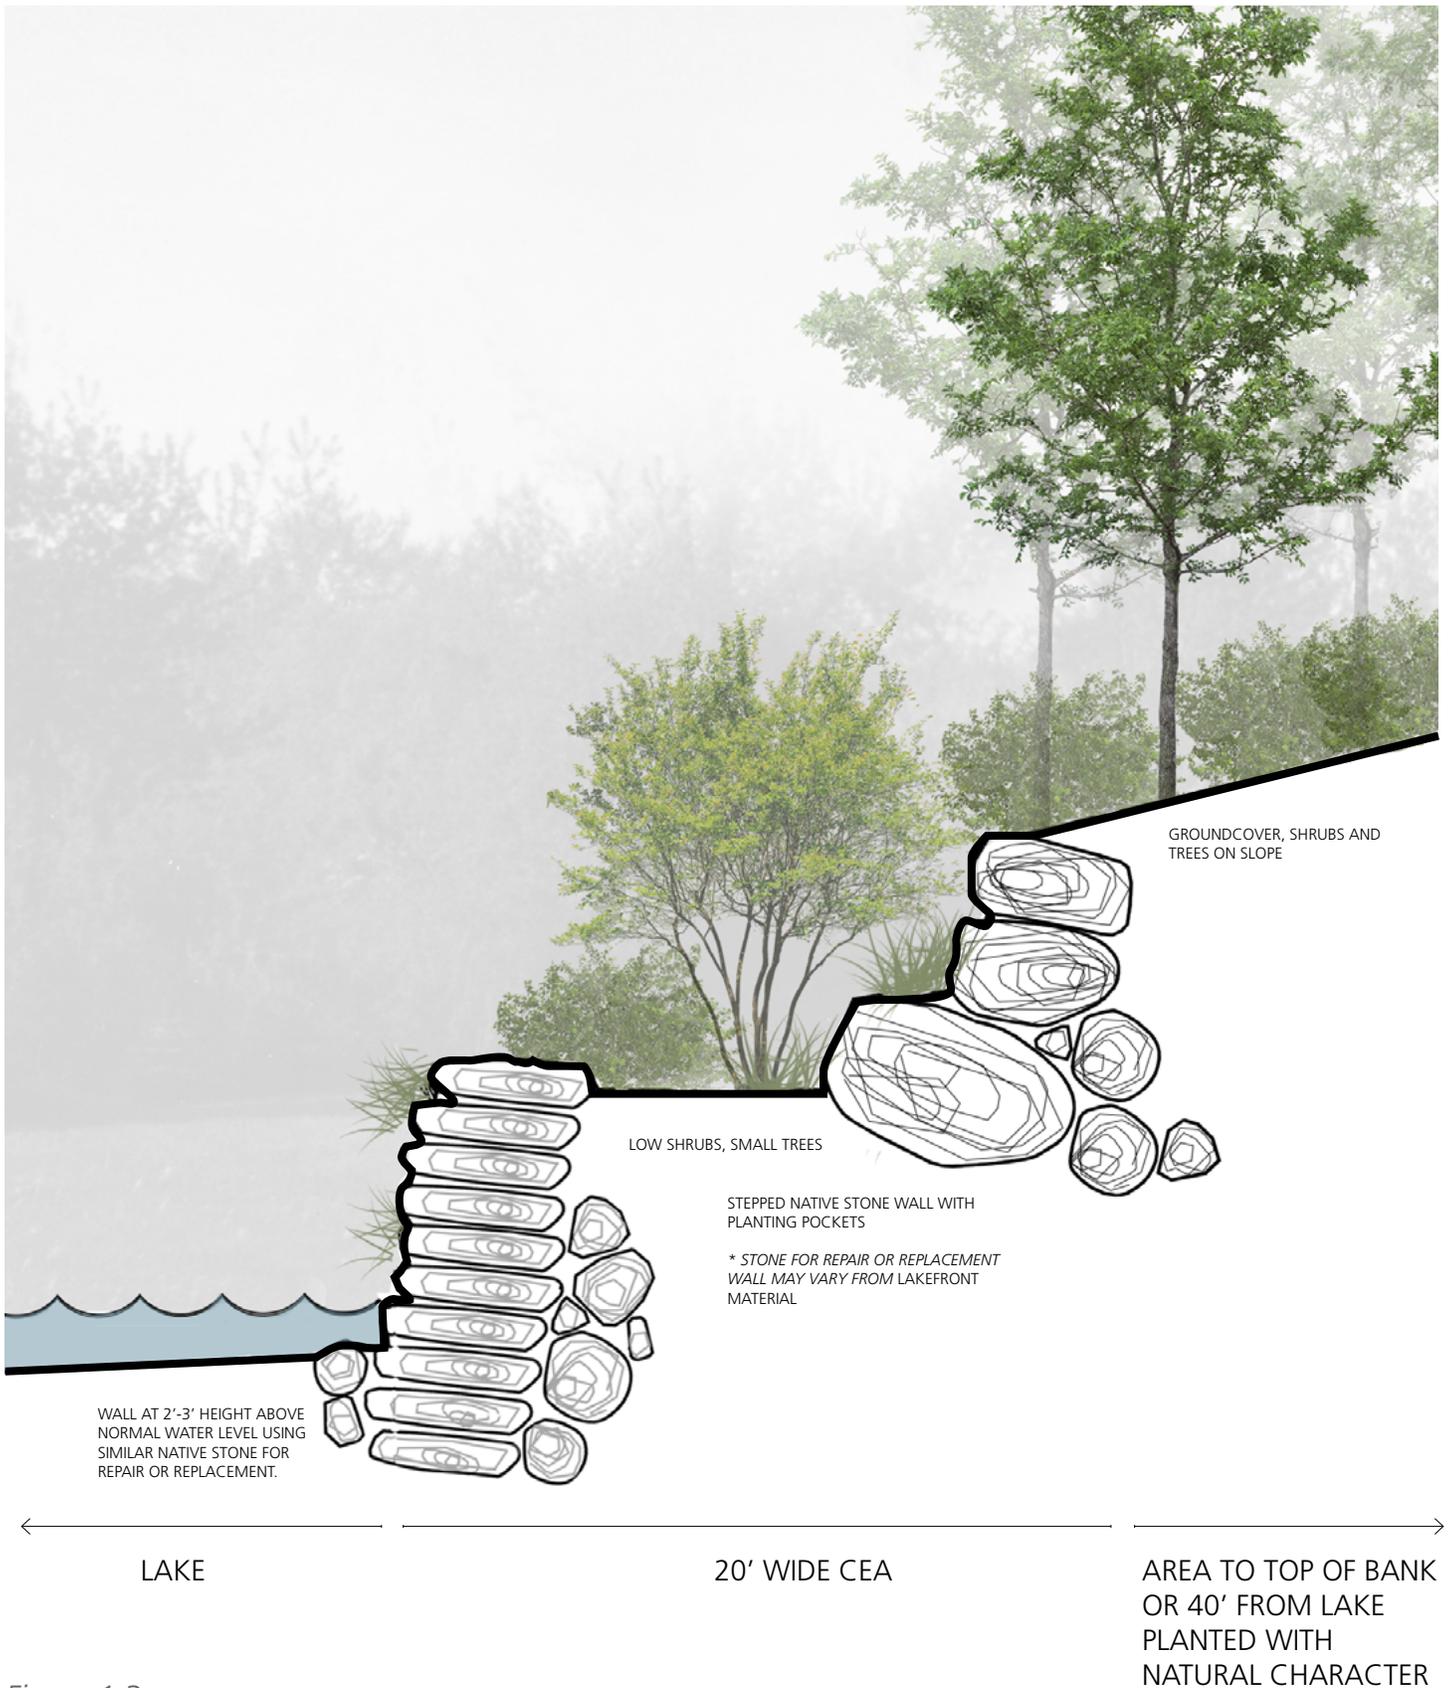
Figure 1.3  
**DISPLAY OF CHARACTER FOR EXISTING  
 STONE WALL REPAIR OR REPLACEMENT  
 IN AREA NOT DEVELOPED**

1. *Repair, stabilization, or replacement of an existing degraded or failing lakefront wall or manmade slope that has existed for more than 10 years.* In-situ wall stabilization or repair should be similar to the original in terms of materials, construction, and configuration. It is appropriate for a replacement of an existing failing or degraded wall to be restored in place, but if feasible, they should be installed using a stepped configuration (+/-2' to 3' height) that includes significant pockets for plantings when viewed from the lake.

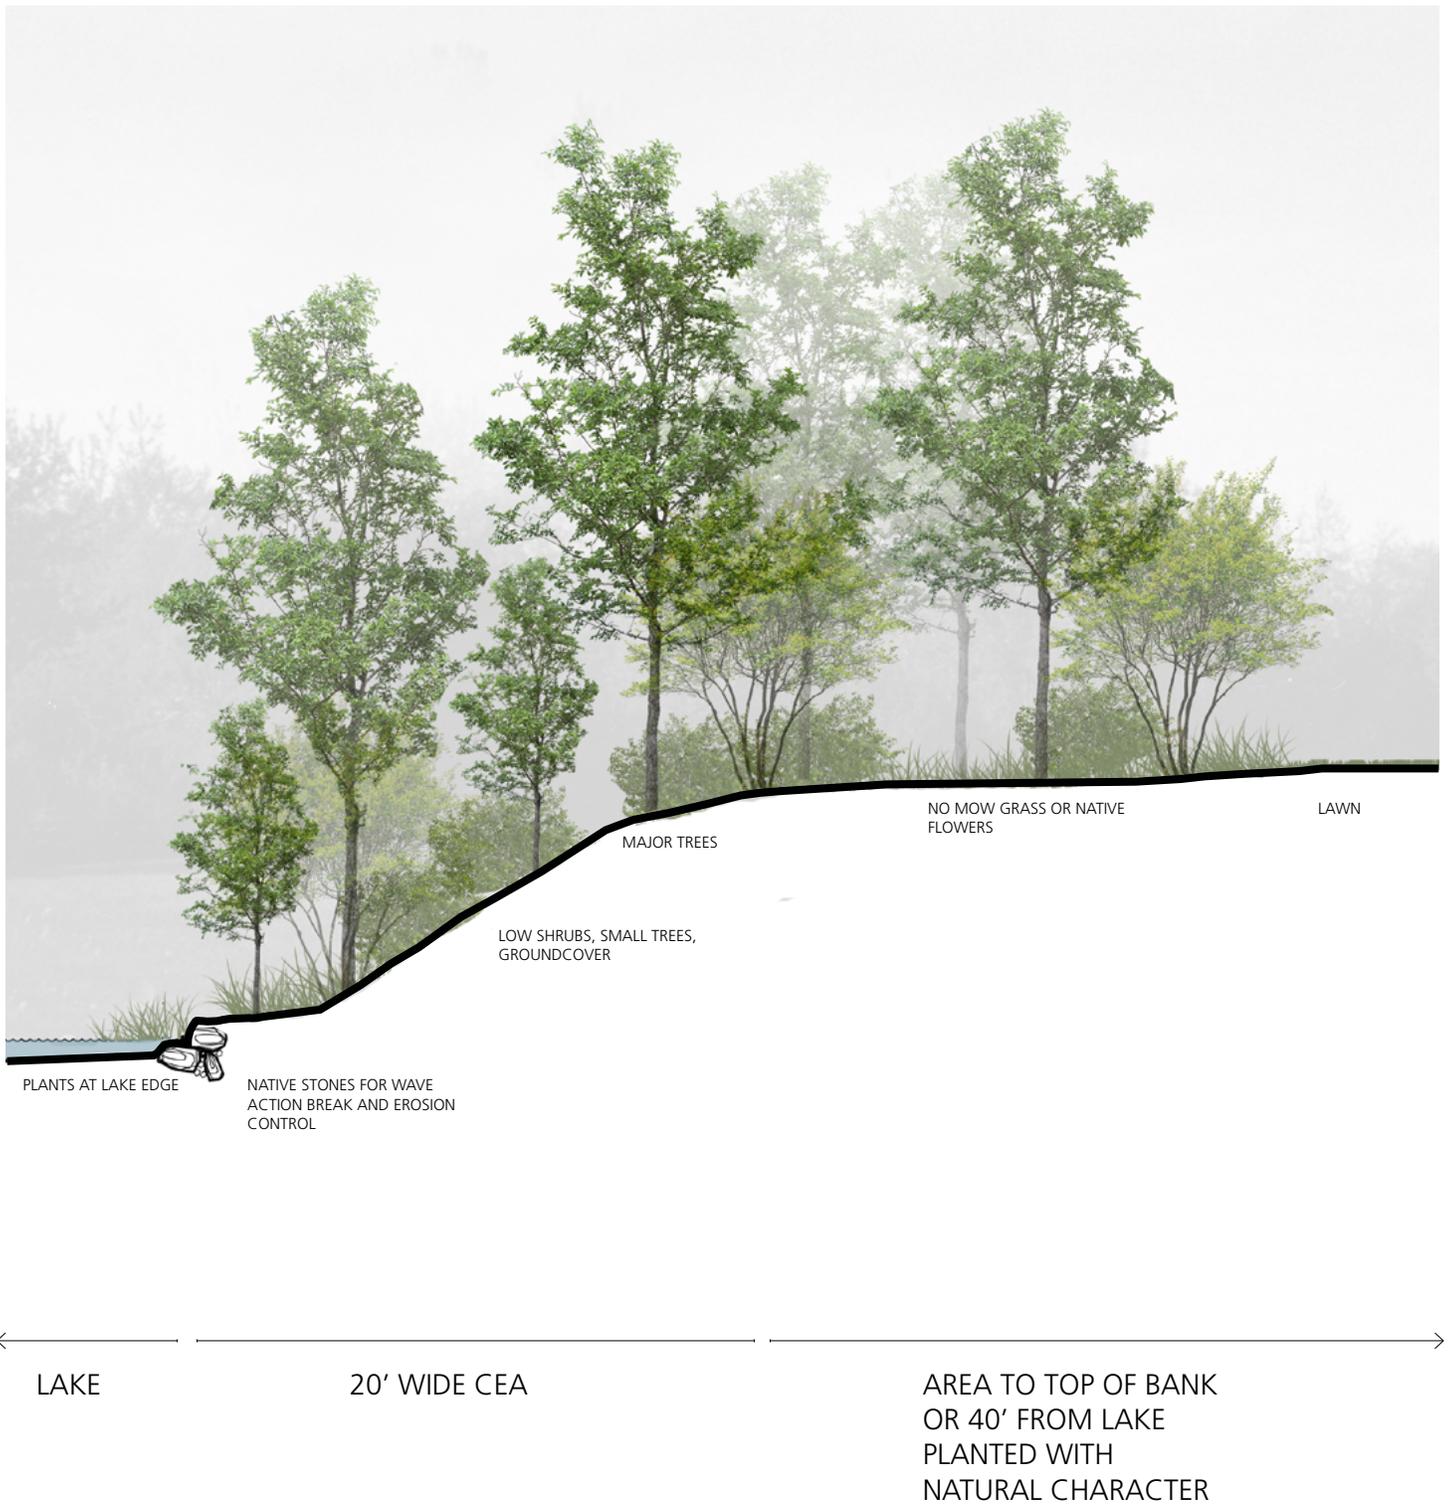
Figure 1.4  
**DISPLAY OF CHARACTER FOR LANDSCAPE AND STABILIZATION OF SLOPES ALONG LAKEFRONT**

When lakefront slope areas are flatter than 1' vertical to 2.5' horizontal within the CEA and/or within 40 feet of the lakefront, a dense growth of soil-holding plant materials should be installed to stabilize the slopes and provide natural or naturalistic visual character along the lakefront. In addition, should an applicant desire to do more with the planted slopes they may consider installation of large boulders or precast concrete units fitted into the slope in a configuration that presents the visual appearance of ledge rock outcrops, surrounded by plant growth, along the shoreline.

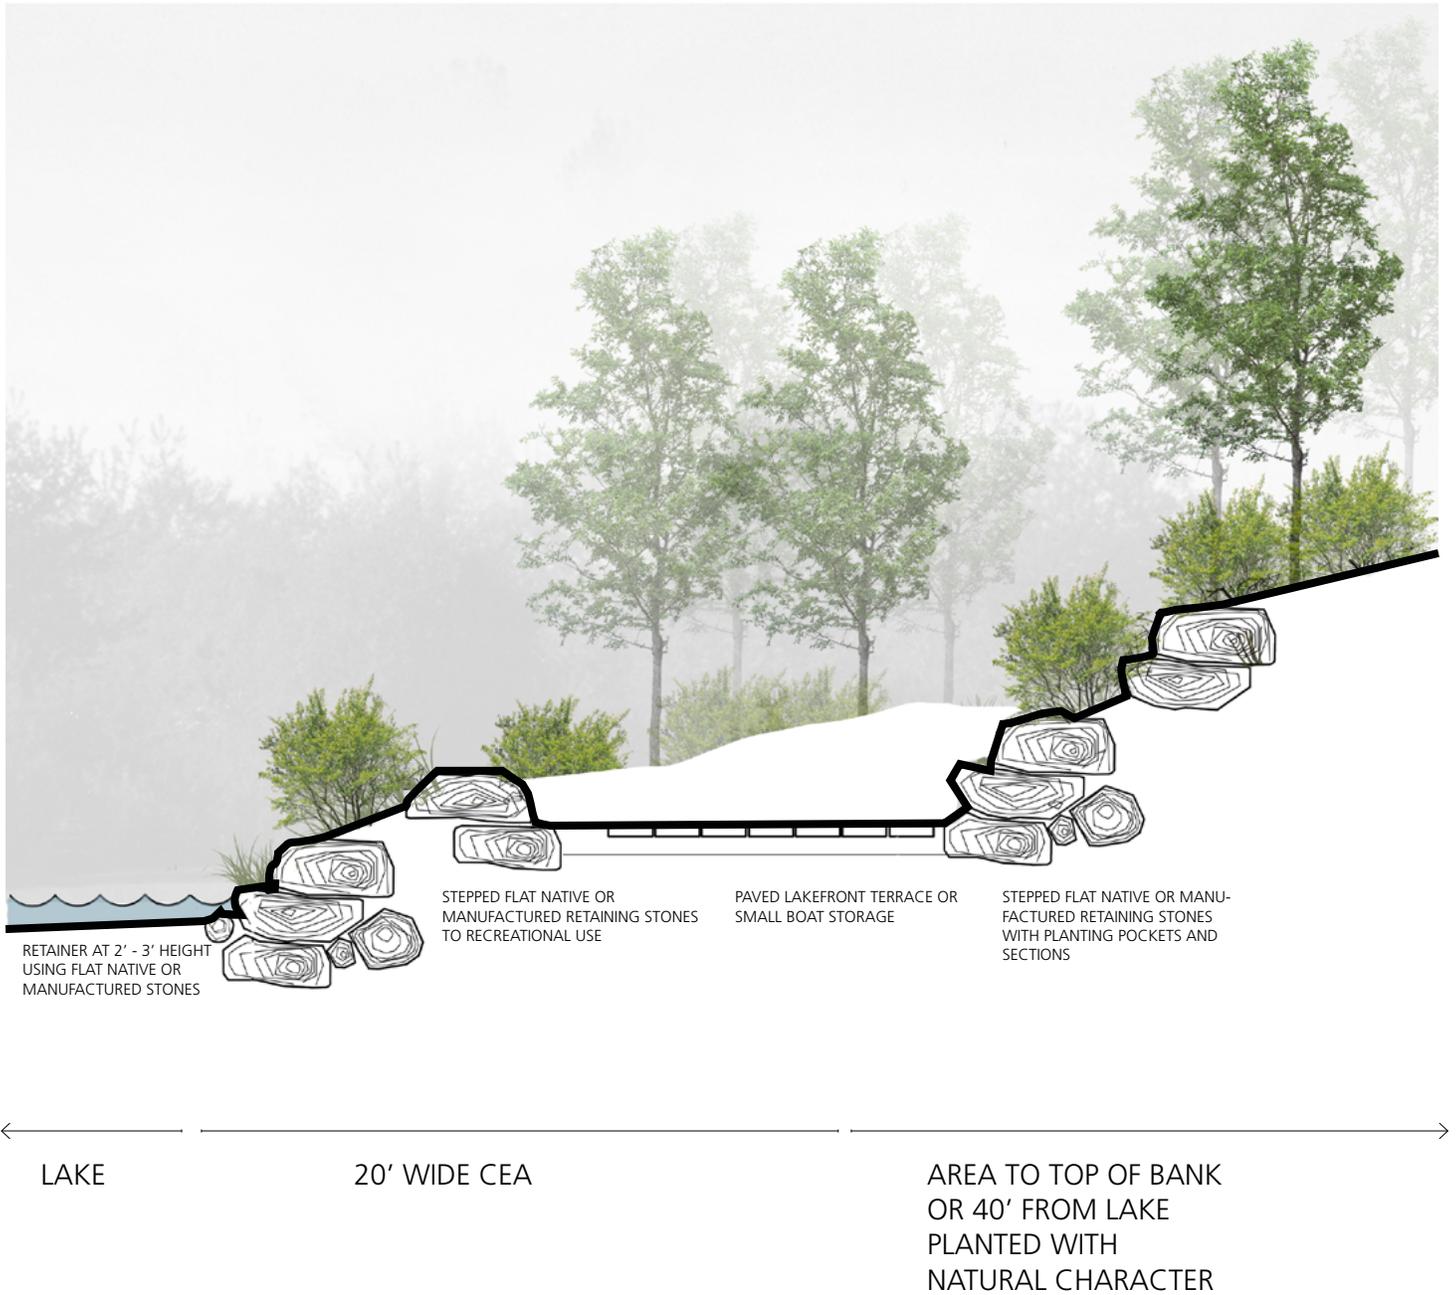
Figure 1.5  
**DISPLAY OF CHARACTER FOR  
 REPLACEMENT WALL WHERE SLOPE  
 STABILIZATION OF DEVELOPED LAKEFRONT  
 IS NOT FEASIBLE.**

Where precast concrete units are considered for use, highly uniform individual units should be avoided. Instead, units that function with a variable size and variable face configuration should be used. In addition, where feasible, they should be installed using a stepped configuration (+/-2' to 3' height) that includes significant pockets for plantings when viewed from the lake.

Cast in place concrete walls should be avoided. However, if needed to retain a lakefront edge or existing long-term lakefront development, such walls should have the face exposed to view from the lake built with a textural character.

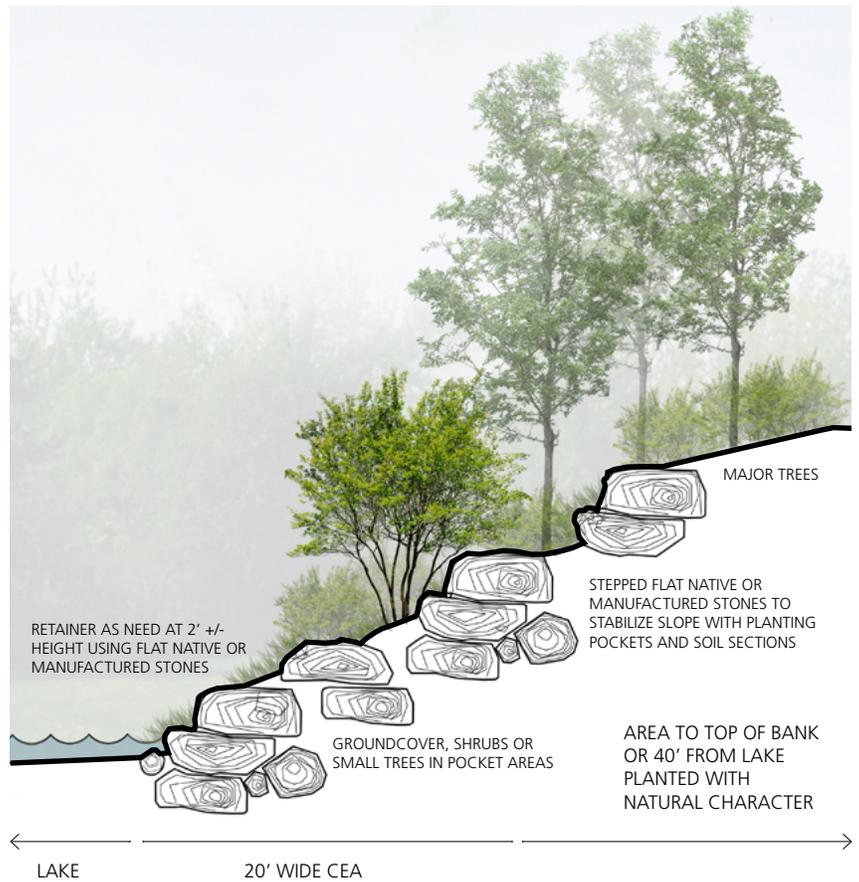
Figure 1.6

### DISPLAY OF SLOPE STABILIZATION WORKING WITH AND AROUND EXISTING PLANTS AND ADDING PLANTS

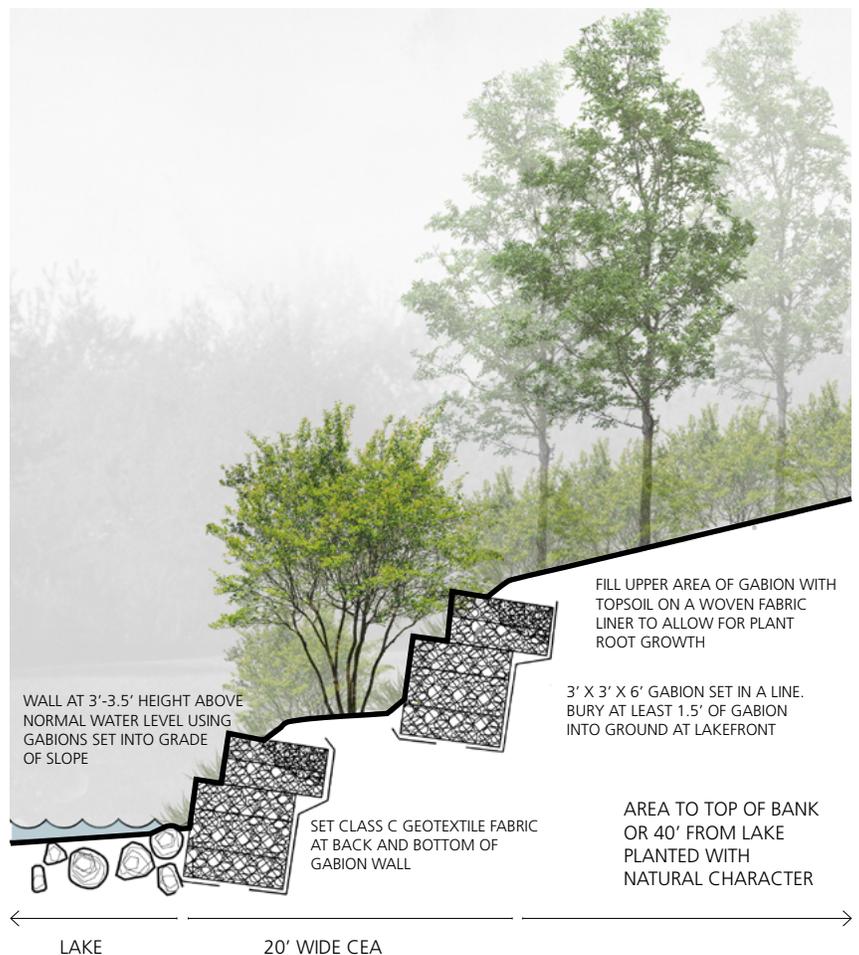
Figure 1.7

### DISPLAY OF CHARACTER FOR EXISTING STONE WALL REPAIR OR USING GABION UNITS

NOTE: GABION FABRIC, TIES, LACING AND CONNECTING WIRES SHALL BE GALVANIZED WITH NOT LESS THAN 0.8 OUNCES PER SQUARE INCH.

2. *Implementation of manmade erosion control practices on slopes greater than 40% (1'vertical/2.5'horizontal).* While not desired, the use of manmade structures may be needed to stabilize eroding natural slopes in locations where existing plant growth is sparse or dominated by diseased species; contains structurally unsound trees; has highly invasive plants; or does not contain plant species with root structures that protect slope soils. Manmade structures may be constructed using stone rip rap, natural stone 'blocks', stone-filled gabions or precast concrete unit materials.

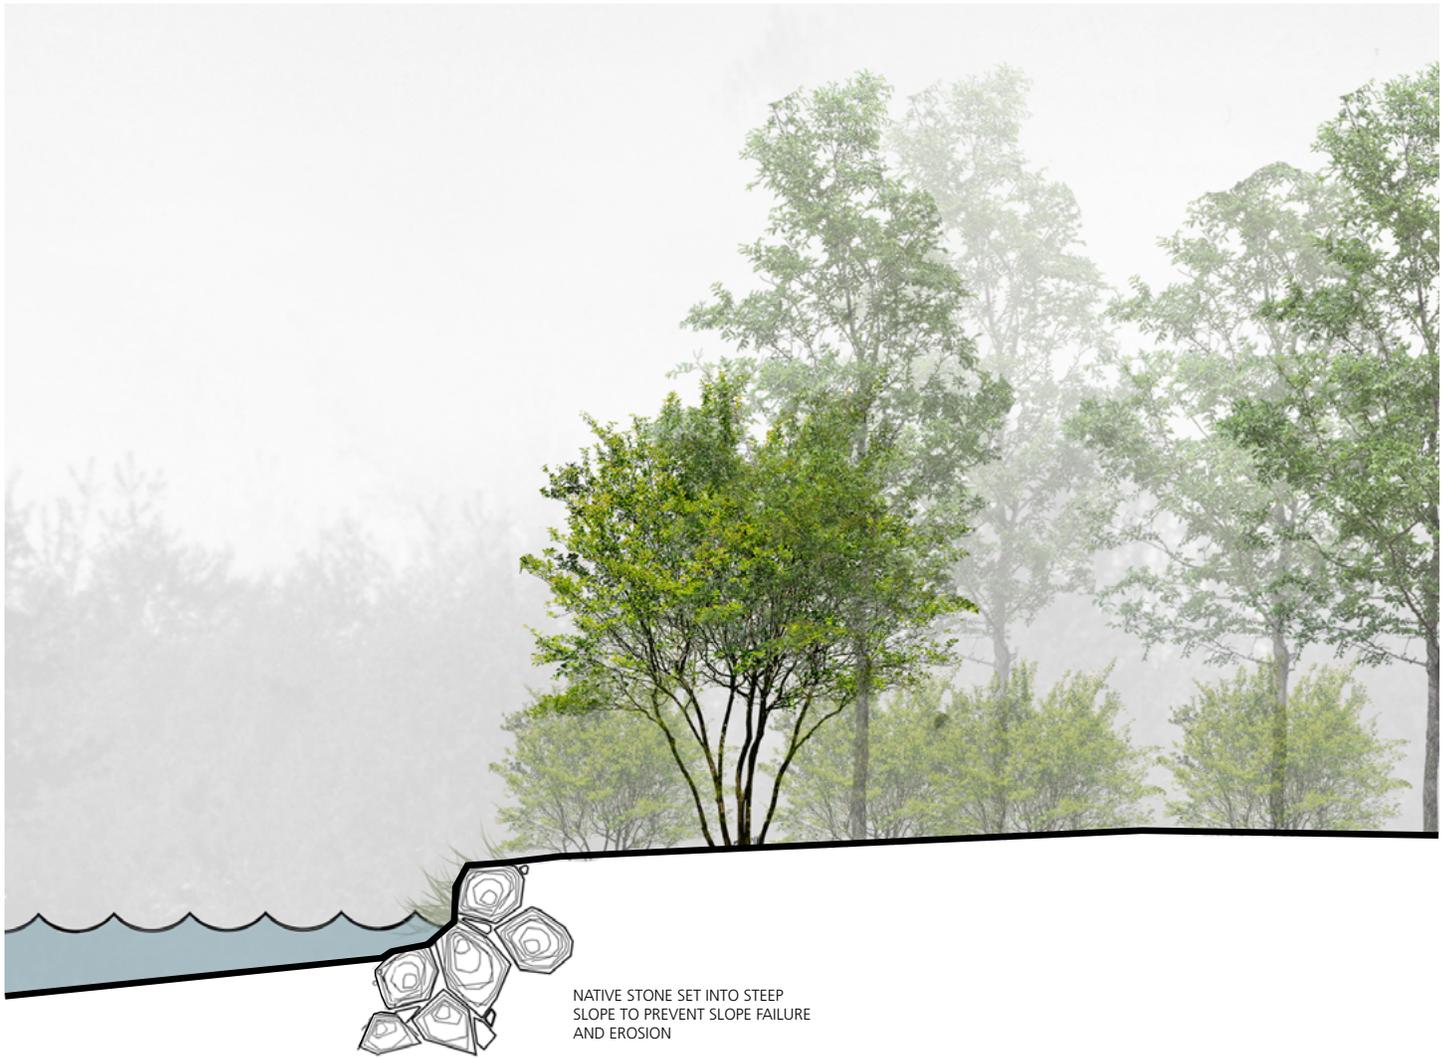
NATIVE STONE SET INTO STEEP SLOPE TO PREVENT SLOPE FAILURE AND EROSION

AREA TO TOP OF BANK  
OR 40' FROM LAKE  
PLANTED WITH  
NATURAL CHARACTER

Figure 1.8  
**DISPLAY OF CHARACTER FOR  
STABILIZATION OF SHORT STEEP SLOPE  
ALONG LAKEFRONT**
