Cazenovia College Redevelopment Study

Completed 2025

MRB
Group

Village of
Cazenovia, NY

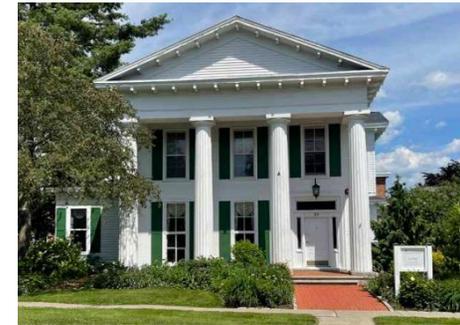
2. Joy Hall

Joy Hall, constructed in 1857 as a single-family home, served as the administrative offices for the President of Cazenovia College until its closure in 2023. This 3,737 square foot, Greek revival historic building appears to be in excellent condition and is listed with the New York State’s Historic Preservation Office. With its impressive two-story doric columns, detailed interior architectural trim, and period elements, it is an architectural jewel of the village and deserves to be maintained. This building could most immediately be used as a high-end business or office space, but could also be converted back to residential or short-term housing consistent with local zoning/code with modification. Due to its historical significance and preservation status, it is considered a high-priority property.

Characteristic	Detail
Year Built	1865
Usable Space (square feet)	3,737
Zoning	C-1, not historic overlay
Current Condition	Good
Sprinklered?	Yes
Number of Elevators	None
Likelihood of Hazardous Building Materials	25%
Most Recent Use	Administrative offices
Original Use (if different)	Residential home
Potential Future Uses	Residential use, short-term housing consistent with local zoning/code, business/office space
Other	Listed with NYSHPO, all-day street parking

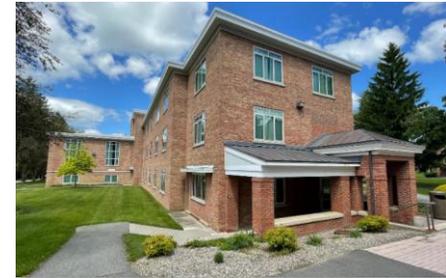
3. Farber Hall

Farber Hall was an all-female college dormitory built in 1959. This building, like many on campus, contains a typical central corridor layout and totals 27,900 square feet over three stories. This configuration makes the building a suitable candidate for conversion into a congregate living facility or senior living facility. Furthermore, while office use or healthcare facilities could be alternative options, the building's floor to ceiling constraints could pose challenges for installing complex mechanical systems that support those types of environments. Nevertheless, it holds high potential for adaptive reuse.

Characteristic	Detail
Year Built	1959
Usable Space (square feet)	27,900
Zoning	C-1, not historic overlay
Current Condition	Good
Sprinklered?	Yes
Number of Elevators	None
Likelihood of Hazardous Building Materials	65%
Most Recent Use	Dormitory
Original Use (if different)	n/a
Potential Future Uses	Congregate living facility, senior living facility, office/healthcare space
Heating/Cooling Systems	Heat- 2 natural gas boilers (~2018 vintage, rated at 1,100,000 BTU/HR) with Baldor 3hp main line pumps. Boilers and piping appear to be in good condition. Multiple Marathon Pumps for circulation, similar vintage but showing moderate corrosion. Cooling – Skid mount chiller (2001 vintage, unverified capacity) circulated by Bell & Gossett ½HP pump. Cooling tower assumed to be of same age.
Other	Central corridor layout, limited ceiling height, limited off-street parking (shared), all-day street parking
Updates Identified by Preliminary Architectural review	In need of new roof, needs elevator, repair/replacement of a corroded metal floor deck, address code violations related to electrical system, replacement of marathon pump for HVAC, and replacement of hot water pump, accessibility upgrades

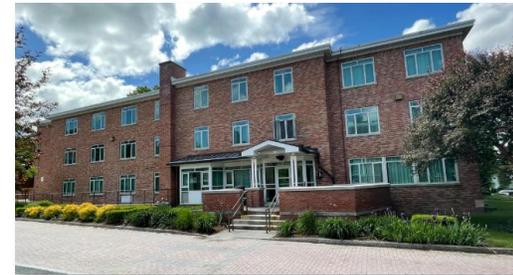
4. Shove Hall

Shove Hall was built in 1966 and operated as a college dormitory. With three stories and 21,000 square feet of space, it shares a similar layout to Farber Hall that includes a central corridor. The central corridor limits the structural modifications that would accommodate drastically different uses. This building is best suited for a program similar in nature to a dormitory such as a congregate living facility or senior living facility. Many of the interior finishes are worn and would require improvements during future work. An alternative use for Shove Hall could be as office space or a healthcare facility, but like Farber Hall, the building's limited height and lack of robust mechanical systems could present challenges.

Characteristic	Detail
Year Built	1966
Usable Space (square feet)	21,000
Zoning	C-1, not historic overlay
Current Condition	Good
Sprinklered?	Yes
Number of Elevators	0
Likelihood of Hazardous Building Materials	70%
Most Recent Use	Dormitory
Original Use (if different)	n/a
Potential Future Uses	Congregate living facility, senior living facility, office/healthcare space
Heating/Cooling Systems	Heat- 2 natural gas boilers (~1997 vintage, rated at 900,000 BTU/HR) with Baldor 3hp main line pumps. Two remote air handlers (~2006) with local circulation pumps only. Boilers and piping show signs of deterioration. Cooling – None
Other	Central corridor layout, limited ceiling height, limited off-street parking (shared), all-day street parking
Updates Identified by Preliminary Architectural review	Roof nearing end of useful life, needs elevator, repair/replacement of a corroded metal floor deck, address code violations related to electrical system, HVAC replacement, addition of mechanical ventilation, sanitary pump replacement, hot water heater replacement, accessibility upgrades

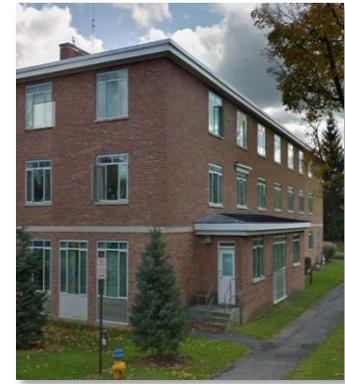
6. Park Hall

Park Hall was built in 1961 and is a three-story, 29,200 square foot building that operated as a college dormitory. The center corridor configuration of the building with small dormitory rooms on the perimeter is a restrictive starting point for adaptive reuse into uses that may require large open space. Maintaining the existing corridor circulation is recommended for ease of conversion. This building has an opportunity to accommodate medium-term residential lodging. Alternatively, the existing building could be utilized as offices for one or multiple tenants. There is adjacent green space available that could be converted to parking, which would bolster the available options for this building. The building has been well maintained and is in excellent condition.

Characteristic	Detail
Year Built	1961
Usable Space (square feet)	29,200
Zoning	C-1, not historic overlay
Current Condition	Excellent
Sprinklered?	Yes
Number of Elevators	0
Likelihood of Hazardous Building Materials	50%
Most Recent Use	Dormitory
Original Use (if different)	n/a
Potential Future Uses	Medium-term residential lodging, office/co-location business space
Heating/Cooling Systems	Heat- 2 natural gas boilers (2007 vintage, rated at 900,000 BTU/HR) and a series of various equipment. Boiler and surrounding pipes show signs of deterioration. Cooling – no central system
Updates Identified by Preliminary Architectural review	Roof warranty for north wing is expired and for west wing expires in 2027. Needs elevator, replace/repair corroded portion of 1 st floor metal deck and at least 6 corroded floor joists, further investigation of flooring system throughout building, address code violations related to electrical system, HVAC replacement, repair corroded connection flange, accessibility upgrades

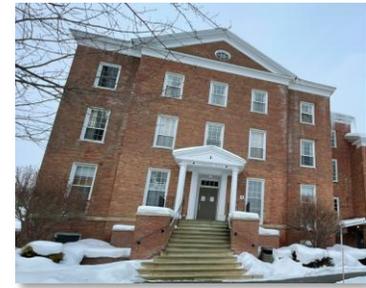
9. Hubbard Hall

Hubbard Hall, constructed in 1827 as part of the original Genesee Seminary, has been central to the campus's evolution over the past two centuries. The building contributed to the institution's transition from a seminary to a junior college in the 1940s, eventually becoming a full co-educational collegiate program by 1982. Hubbard Hall has seen both minor and major renovations throughout its history. In 1959, a fire tragically destroyed the neighboring Callahan Hall, making room for the expansion of New Hubbard Hall. This addition included a dining hall and commercial kitchen facilities on the first floor, with student housing on the upper levels. The building's layout makes it well-suited for potential conversion into hotel-style accommodations or residential spaces, with ground-floor conference, gathering, and dining areas. The second and third floors could accommodate approximately twenty-six double-queen occupancy rooms. Alternative uses, such as office or healthcare facilities, are also viable, although the building's height may pose challenges for the mechanical clearances required in these types of conversions.

Characteristic	Detail
Year Built	1827/1960's
Usable Space (square feet)	60,538
Zoning	C-1, not historic overlay
Current Condition	Old portion in fair condition. New portion in good condition.
Sprinklered?	Yes
Number of Elevators	1
Likelihood of Hazardous Building Materials	30%
Most Recent Use	Dormitory and dining hall
Original Use (if different)	n/a
Potential Future Uses	Hotel-style lodging with conference and dining spaces, residential, office/healthcare space
Heating/Cooling Systems	Shared system for Hubbard, Eddy, Coleman, and Williams Heat - 4 natural gas boilers (2019 vintage, rated at 850,000 BTU/HR) with primary loop pumps and 2 Bell & Gossett 7.5HP pumps. Entire system appears to have been updated in 2019. Heating/Cooling – 1 packaged roof top unity with natural gas heating (224,000 BTU/HR) and Dx cooling (114,000 BTU/HR) Separate systems may be needed for each building to accommodate future uses.

Updates Identified by Preliminary Architectural review	Old portion: Window repair/replacement, concrete stair replacement, investigation of wall cracking, maintenance of electrical distribution panels, plumbing fixture repairs/replacement New portion: Roof replacement, truck dock improvements, repair of service elevator, Both: ventilation improvements, masonry repointing, address electrical code violations, accessibility upgrades
--	---

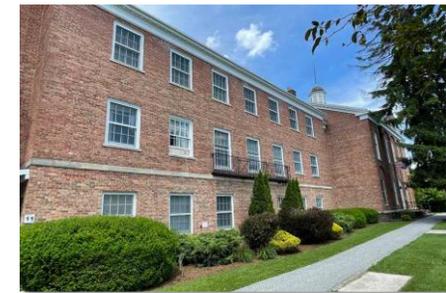
10. Eddy Hall

Eddy Hall, one of the oldest buildings on campus, was constructed in 1827 as part of the original Seminary. In the late 1950's, renovations allowed connections to be made to neighboring buildings Coleman, Williams, and Hubbard Halls. A unique feature of Eddy Hall is its 8-stop elevator, which serves the four interconnected buildings despite their varying floor heights. Potential future uses for Eddy Hall include conference breakout rooms, adult education, or training facilities. Alternatively, it could be adapted for office or healthcare functions. However, like other campus buildings, its limited height poses challenges for certain healthcare mechanical systems and infrastructure.

Characteristic	Detail
Year Built	1827/1959
Usable Space (square feet)	Approximately 8,400
Zoning	C-1, not historic overlay
Current Condition	Good
Sprinklered?	No
Number of Elevators	1 (8-stop elevator accommodates the varying floor heights of the four interconnected buildings)
Likelihood of Hazardous Building Materials	20%
Most Recent Use	Educational instruction
Original Use (if different)	n/a
Potential Future Uses	Conference breakout rooms, adult education/training facilities, office/healthcare space
Heating/Cooling Systems	Same as Hubbard
Updates Identified by Preliminary Architectural review	Masonry repointing, shed roof replacements, wood window and trim restoration, additional elevator, investigation and potential repair of corroding metal floor decks and joists, address electrical code violations, accessibility upgrades

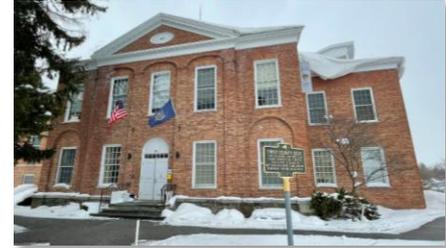
11. Coleman Hall

Coleman Hall was built in 1961 and functioned as an educational instruction building for Cazenovia College. Located between Eddy and Williams Halls, it is best suited for uses such as conference breakout rooms or adult education/training facilities. Alternatively, it could be repurposed for office use or healthcare, though, like other buildings on campus, the limited height of the structure may pose challenges for certain mechanical systems. Like Eddy Hall, the ability to convert this building to residential is limited due to a lack of a sprinkler system and elevator.

Characteristic	Detail
Year Built	1961
Usable Space (square feet)	8,500
Zoning	C-1, not historic overlay
Current Condition	Good
Sprinklered?	No
Number of Elevators	0
Likelihood of Hazardous Building Materials	25%
Most Recent Use	Educational instruction
Original Use (if different)	n/a
Potential Future Uses	Conference breakout rooms, adult education/training facilities, office/healthcare space
Heating/Cooling Systems	Same as Hubbard
Updates Identified by Preliminary Architectural review	Severe ice dam conditions develop on roof, should be addressed to prevent water damage and safety hazards. Masonry repointing, window repair/replacement, investigate and address water damage on façade and roof eaves, investigation and potential repair of corroding metal floor decks and joists, address electrical code violations, maintenance of electrical distribution panels, accessibility upgrades

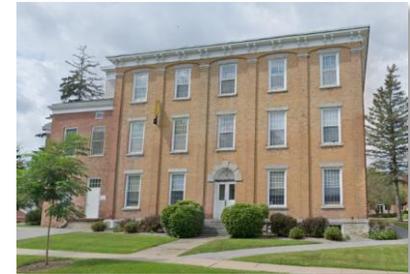
12. Williams Hall

Williams Hall, constructed in 1854, is one of the oldest buildings on the Cazenovia College campus. Over the years, it has served multiple purposes, including housing enrollment services, career services, and adult continuing education programs. In the 1960s, modifications to the building impacted its original architectural integrity, which ultimately led to its exclusion from the Cazenovia Village Historic District. Once a standalone structure, Williams Hall is now physically connected to Coleman Hall and Eddy Hall. Given these connections and the challenges of adaptive reuse, the most effective approach would be to assign Williams Hall to a program or function that complements the future uses of Coleman and Eddy Halls.

Characteristic	Detail
Year Built	1854/1961
Usable Space (square feet)	7,965
Zoning	C-1, not historic overlay
Current Condition	Good
Sprinklered?	No
Number of Elevators	0
Likelihood of Hazardous Building Materials	20%
Most Recent Use	Administrative offices
Original Use (if different)	Part of the original Genesee Seminary
Potential Future Uses	Program/function that aligns with Coleman and Eddy Halls
Heating/Cooling Systems	Same as Hubbard
Updates Identified by Preliminary Architectural review	Ice dam conditions develop on roof, should be addressed to prevent water damage and safety hazards. First-floor framing shows visible low areas, but framing on other floors was not visible. More thorough investigation of the floor framing should be conducted on all floors, and any bearing issues addressed. Basement is under-conditioned and damp. Repointing of limestone and masonry, exterior wood trim repairs, window and door repair or replacement, address electrical code violations, maintenance of electrical distribution panels, accessibility upgrades

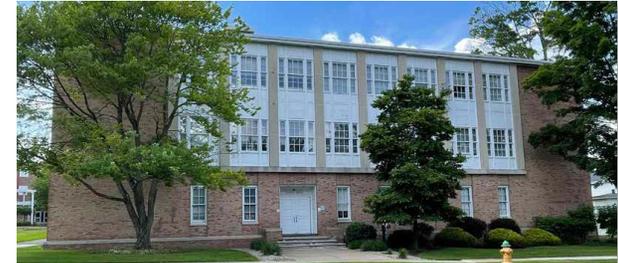
13. Eckel Hall

Eckel Hall, a three-story educational building constructed in 1967, originally served as a lecture hall and classroom facility. In 2014, partial renovations were made to the third floor, adding new science laboratories and support spaces. The building's current layout and past use make it well-suited for potential conversion into a commercial research and development facility, computer labs, or office spaces.

Characteristic	Detail
Year Built	1967/2014
Usable Space (square feet)	22,940
Zoning	C-1, not historic overlay
Current Condition	Good
Sprinklered?	Yes, 3 rd floor
Number of Elevators	1
Likelihood of Hazardous Building Materials	10%
Most Recent Use	Educational instruction
Original Use (if different)	n/a
Potential Future Uses	Commercial research and development, computer labs, or offices
Heating/Cooling Systems	Heat – 1 natural gas boiler (~2014 vintage, rated 399,000 BTU/HR), similar vintage pumps, controls, and disconnects. All appear in good condition. Note that the boiler appears to be within the footprint of the library building. Cooling - exterior pad mounted Carrier split system provides Dx cooling to an air handler (~2008 vintage)
Other	All-day street parking, no dedicated parking
Updates Identified by Preliminary Architectural review	Removal of exterior vegetation on building walls and related masonry repair, investigate and repair areas of water infiltration, inspect water main backflow, address electrical code violations, maintenance of electrical distribution panels, accessibility upgrades

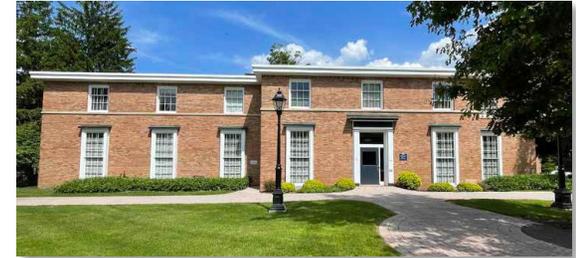
14. Witherill Hall Library

Witherill Hall was built in 1964 and was previously home to Cazenovia College’s Frederic and Jean Williams Archives and the Wason Family Reading Room. The building’s configuration with a large structural grid and high ceilings combined with smaller, private offices creates an opportunity for supporting flexible and/or shared commercial operations or community use. The larger spaces could be separated into numerous smaller offices and rooms, or could be utilized as communal space like waiting rooms, open office space, lounge areas, etc. The higher ceiling heights in these spaces also offer more flexibility for upgrading mechanical infrastructure, which could support different uses like medical or residential. However, other areas of the building have limited clearance between floors, making it challenging to install new equipment for these uses.

Characteristic	Detail
Year Built	1964
Usable Space (square feet)	19,215
Zoning	C-1, not historic overlay
Current Condition	Good
Sprinklered?	No
Number of Elevators	1
Likelihood of Hazardous Building Materials	10%
Most Recent Use	Library, archives and reading room
Original Use (if different)	n/a
Potential Future Uses	Flexible commercial or community use, partial residential or medical use
Heating/Cooling	Heat – 1 natural gas boiler (~2019 vintage, rated 210,000 BTU/HR), similar vintage pumps, controls, and disconnects. All appear in good condition. Cooling - exterior pad mounted Daikin cooling tower (2013 vintage) supplying chilled water to existing air handling system. Heating coils are no longer connected. Air handling units are at end of useful life.
Other	Not directly adjacent to parking, equidistant from street parking
Updates Identified by Preliminary Architectural review	Removal of exterior vegetation on building walls, masonry repointing, window maintenance and repairs, installation of mechanical ventilation system, replace air handling units and fans, plumbing fixture replacement, lift station pump and control replacement, address electrical code violations, maintenance of electrical distribution panels, accessibility upgrades

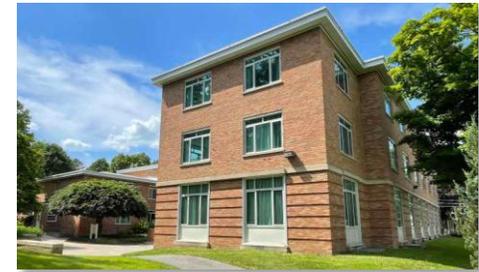
18. Campus Center at Watts Hall

The Campus Center at Watts Hall, which was built in 1964 and used as a dormitory until 2018 when it was converted to staff and administrative offices, is well-suited for individual offices due to its three-story layout and center corridor. As with adjacent buildings, maintaining the existing corridor circulation is recommended for ease of conversion. Alternatively, this building could be converted into a healthcare facility, but the limited height of the building might pose complications for mechanical systems and infrastructure. A feature of this building is its proximity to an existing visitor parking lot on Nickerson Street and potential for additional parking with conversion of a green space.

Characteristic	Detail
Year Built	1964
Usable Space (square feet)	32,660
Zoning	C-1, not historic overlay
Current Condition	Good
Sprinklered?	Yes
Number of Elevators	0
Likelihood of Hazardous Building Materials	50%
Most Recent Use	Administrative and faculty offices
Original Use (if different)	Dormitory until 2018
Potential Future Uses	Business/office space, healthcare facility
Heating/Cooling	Heat – 1 natural gas boiler (~2010 vintage, rated 1,060,000 BTU/HR). Boiler and primary loop has significant useful life and the secondary heating loop pump motors appear to have been replaced in January 2025. Surrounding components are in poor condition. Remote air handler (2006 vintage) has heat capacity only. Cooling – None
Other	Center corridor layout, limited ceiling height, shared parking lot, and all-day street parking
Updates Identified by Preliminary Architectural review	Roof replacement, investigate and address water infiltration, repair of corroding metal floor decks and joists, component repair of main boiler, addition of mechanical ventilation, hot water heater replacement, removal of abandoned equipment, address electrical code violations, accessibility upgrades

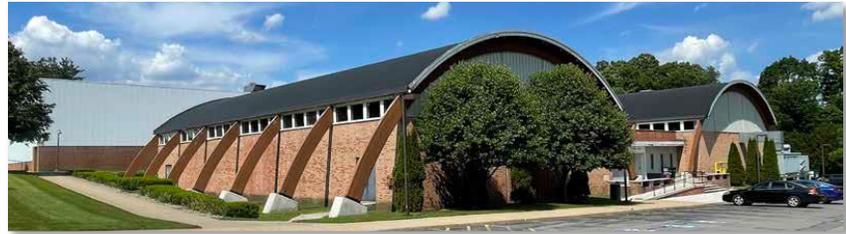
21. Stephen M. Schneeweiss Athletic Complex

The Stephen M. Schneeweiss Athletic Complex, built in 1968, has long been a valuable asset to both the college and the local community. A recent visual assessment of the facility found it to be in overall good condition. The maintenance team noted that the Upper Gym was renovated in 2012 with new floors and bleachers. They also indicated a portion of the existing roof require will require replacement in the near future. Given the limited availability of sports facilities for community use—particularly pools—continued community access to this complex is recommended. Minor additional improvements and repairs may be required over the next five years to maintain the facility's operational standards. Located one block from the main campus, the complex includes most of the college's parking and features an outdoor turf field, installed in 2012, which remains in good condition. Despite the ongoing community use of the complex, portions of the parking area and/or outdoor field space not essential for community use could potentially be subdivided for neighborhood development. Prior to any development, however, an assessment of the surrounding neighborhood's infrastructure capacity would be necessary to support such expansion.

Characteristic	Detail
Year Built	1968
Usable Space (square feet)	52,478
Zoning	C-2, not historic overlay
Current Condition	Good – portion of roof needs replacing
Sprinklered?	No
Number of Elevators	1
Likelihood of Hazardous Building Materials	5%
Most Recent Use	Multi-purpose athletic space
Original Use (if different)	n/a
Potential Future Uses	Community athletic uses
Other	Minor repairs/improvements expected in next 5 years, substantial parking facilities
Updates Identified by Preliminary Architectural review	Roof replacement between barrel roofs, masonry repointing, repaint exterior wood trim and siding, repair of corroding metal floor decks and joists, repair or replace smoke hatches, service pool

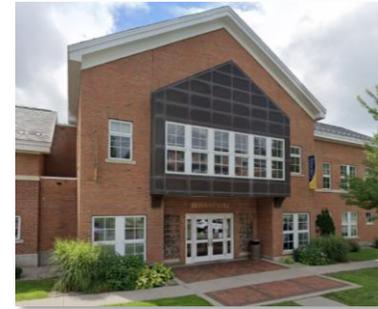
24. Reisman Hall

Reisman Hall, constructed in 2004 as an art and design building, is well-suited for future use as a high-end business and retail space. Having been constructed 20 years ago, it is configured in a more modern, adaptable way than many other buildings on campus, giving it the potential flexibility to accommodate a variety of commercial uses. Additionally, this building is situated on the corner of Seminary Street and Sullivan, allowing a public facing entrance that feels separated from the private entrances. Conversion to other uses like residential may be possible, but would likely require substantial adjustments to the building.

Characteristic	Detail
Year Built	2004
Usable Space (square feet)	22,000
Zoning	C-1, historic overlay
Current Condition	Excellent
Sprinklered?	Yes
Number of Elevators	1
Likelihood of Hazardous Building Materials	2%
Most Recent Use	Art and design building
Original Use (if different)	n/a
Potential Future Uses	High-end business and retail space
Heating/Cooling	Heat – 2 natural gas boilers (~2004 vintage, rated 200,000 BTU/HR each). Equipment, piping, and pumps appear to be in good condition. Cooling – exterior Evapco base mounted open cooling tower (2004 vintage).
Other	Adaptable layout, parking lot with 6 spaces, all-day street parking
Updates Identified by Preliminary Architectural review	Investigate and address ice damming, exterior wood restoration, cooling tower and boiler replacement, investigate/remediate main RPZ/backflow, address electrical code violations

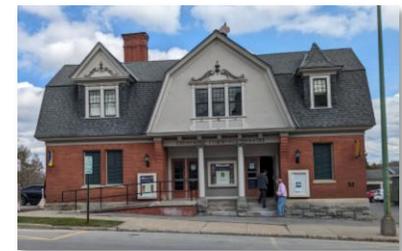
26. Catherine Cummings Theatre

Catherine Cummings Theatre, a community theatre built in 1896, is a historic gem of the Village and was used for a variety of cultural events, including drama, dance, lectures, and more. Due to its historic and cultural significance, no changes in use are recommended and it should be prioritized for regular maintenance checks to ensure no irreparable damage occurs during this period of vacancy. The theatre remains a high-potential asset for the community.

Characteristic	Detail
Year Built	1896
Usable Space (square feet)	9,000
Zoning	B-1, historic overlay
Current Condition	Good
Sprinklered?	No
Number of Elevators	0
Likelihood of Hazardous Building Materials	5%
Most Recent Use	Community theatre
Original Use (if different)	Opera house
Potential Future Uses	Community theatre and space for cultural events
Other	2-hour street parking, limited alley spaces
Updates Identified by Preliminary Architectural review	Restoration of exterior ramp and stairs, entrance door replacement, interior stair structure improvements, accessibility improvements

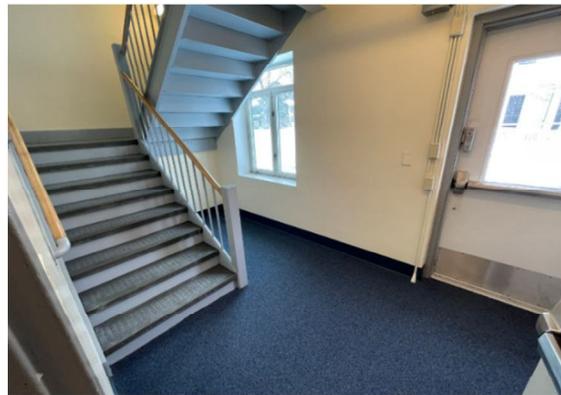
The building requires additional accessibility accommodation improvements. The last major update to the building was in 1999 and no additional accessibility measures have been implemented in the twenty-six years since. This building does not have an elevator. If future use of this building requires a change in occupancy type, it is likely that an elevator will be required to meet accessibility requirements. Additionally, the toilet rooms would require updates to provide code compliant turn radii, grab bars, and fixtures. The stairwell stairs will need to have the railing modified to provide 12" extensions if applicable as well as a guard under the stairs to prevent low headroom injury.

Typical stairwell - improvements to the handrails recommended

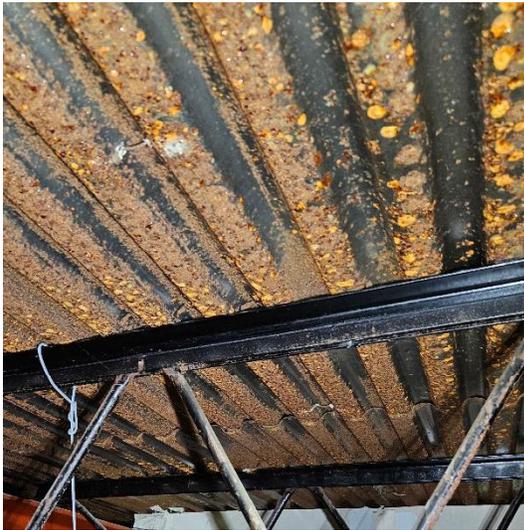
Heavy surface corrosion at metal deck

- Extensive surface rust was noted at the bottom face of the first-floor metal deck where visible at the north wing of the building.
- Varying levels of surface rust were noted on the open web steel joists supporting the first-floor deck at the north wing of the building.

- The basement ceiling finishes should be removed to allow a full structural assessment of the existing first-floor metal deck and open web steel joists, ensuring a thorough evaluation of the extent and severity of the observed corrosion. At a minimum, surface rust on the metal deck and steel joists should be removed, followed by the application of a protective zinc-rich paint to the cleaned metal surfaces to prevent future corrosion.
- The structural assessment may uncover localized areas of the metal deck and steel joist floor system that have progressed to a point where reinforcement and/or replacement is necessary, though this was not encountered during the field walkthrough.

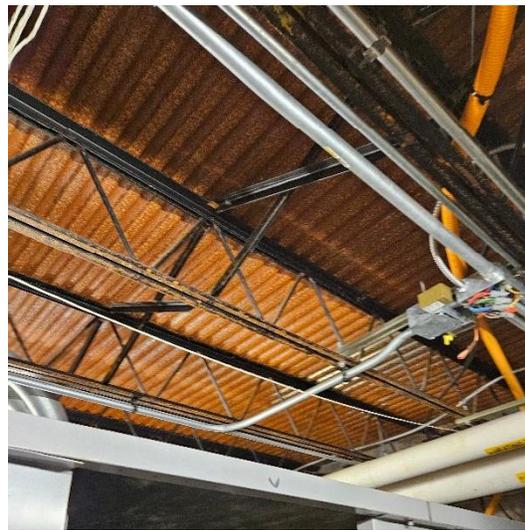
Metal deck and OWSJ corrosion

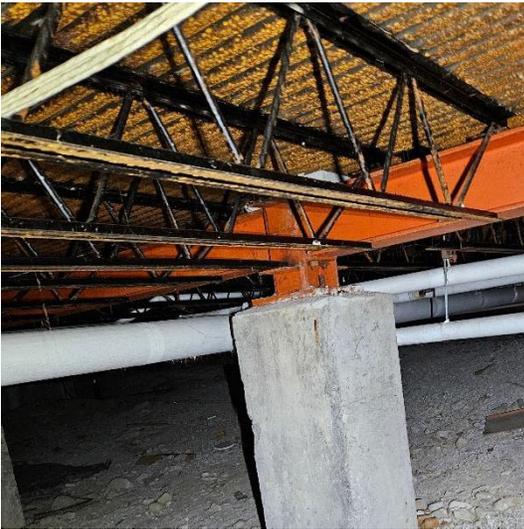
Metal deck and OWSJ corrosion

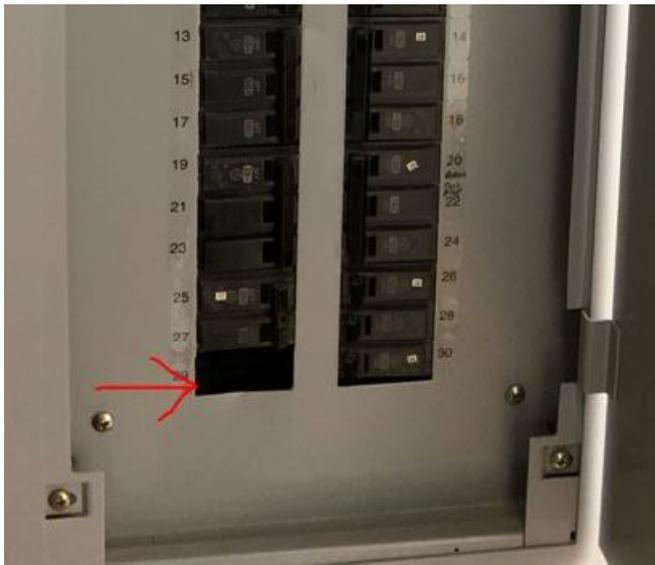
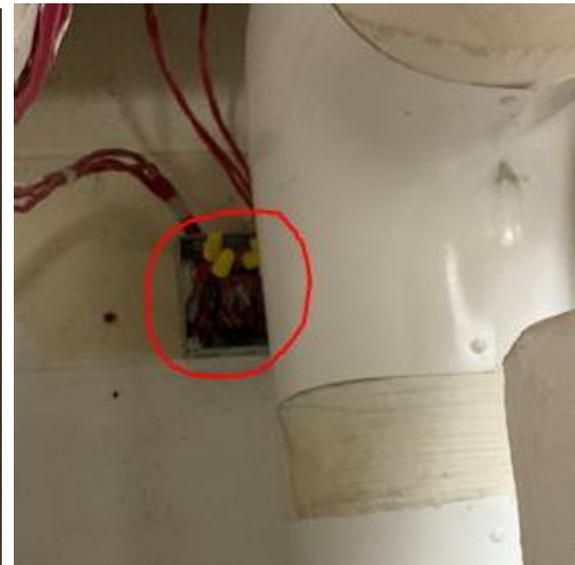
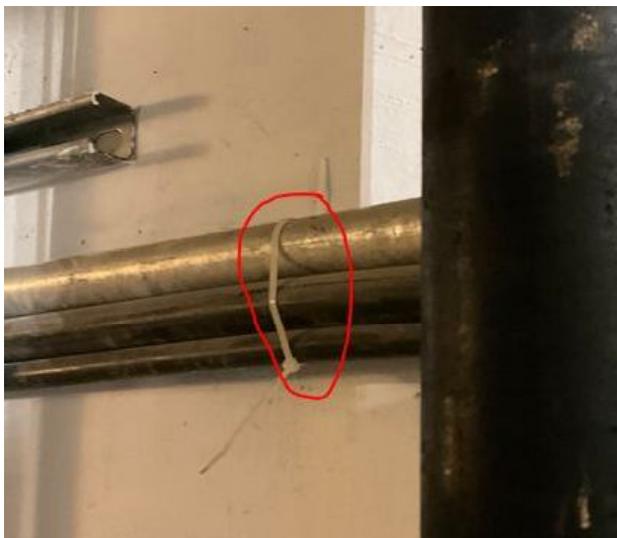
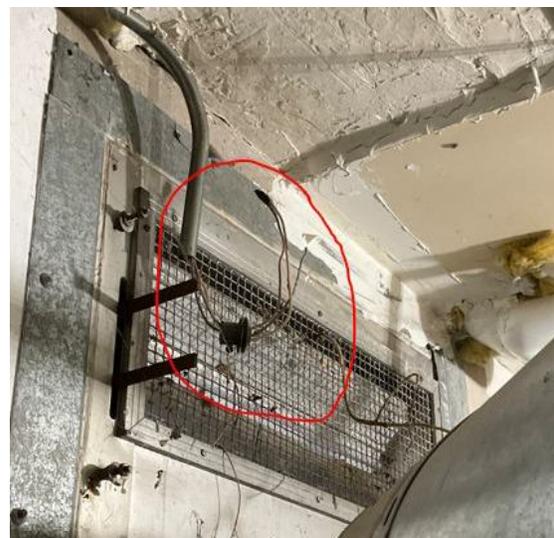
As mentioned within the evaluation section above, most electrical distribution equipment appears to be from the 1990's renovation project. The equipment has reached the end of its useful life, but everything appears to be in good overall condition. The only deficiencies noted during the site visit included missing circuit breaker filler plate in a panel, wires zip-tied to conduits, loose exposed wires, and missing junction box covers. Our recommendation is to correct these safety concerns/code violations.

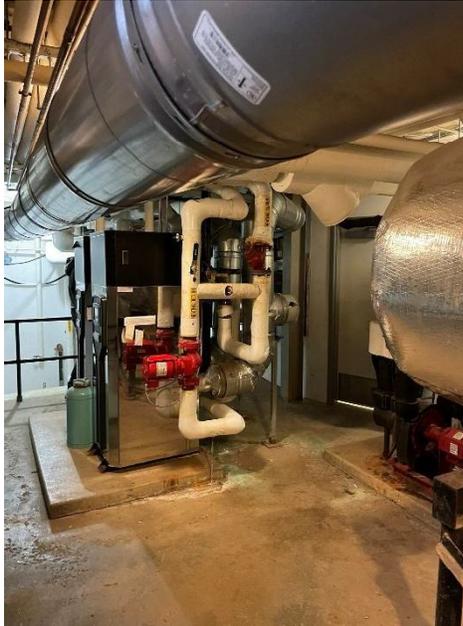
Existing boilers

The building's central heating system consists of two natural gas boilers that send hot water out to various equipment such as fan coil units, cabinet unit heaters, cabinet unit ventilators, and two air handlers. The boilers are approximately 2018 vintage and are rated at 1,100,000 BTU/HR each. The boilers and surrounding piping appear to be in good condition. The primary hot water boiler loop circulation is provided by 1HP Marathon pumps, which also appear to be in good condition and have approximately the same vintage as boilers. From there, the main hot water supply and return to the secondary heating devices are circulated by two Marathon 10HP base mounted pumps. These Marathon pump motors appear to have replaced original Bell & Gossett as the B&G body remains. These pumps have moderate corrosion at flange locations and should be reviewed for replacement.

In general, the visible systems are in fair condition and have serviceable life remaining. However, with most of the equipment approaching 20 years in use, replacement should be considered as part of any upcoming project. Heating hot water base mounted pumps should be reviewed for replacement. Other than the limited areas served by air handlers, there is little-to-no mechanical ventilation system in place. If planned usage of the building changes from current use, a forced air mechanical system may be required to be installed to meet current ventilation code requirements.

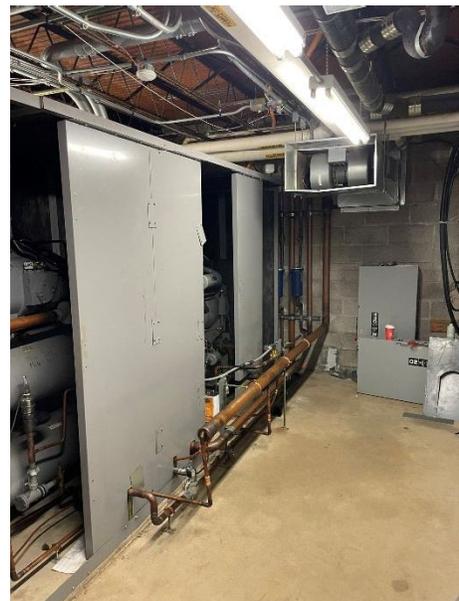
The central cooling system is supported by a skid mounted chiller within the basement area. The capacity of the chiller was unable to be verified during the visit, but nameplate information provided a build year of 2001. Chilled water circulation is performed by a Bell & Gossett 1/2HP pump. Cooling tower is remote pad mounted unit assumed to be same vintage as chiller. This system is in relatively good condition and the expected useful life of this type of equipment is 25-30 years.

Skid mounted chiller

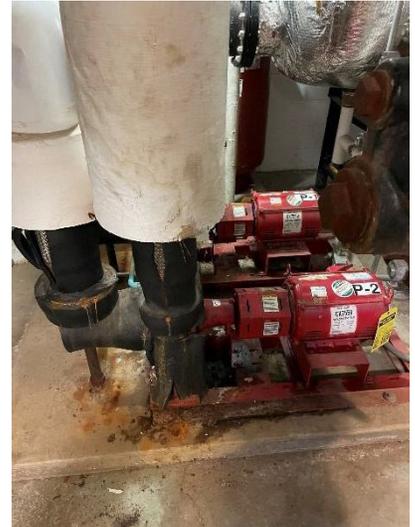
Deteriorated pumps

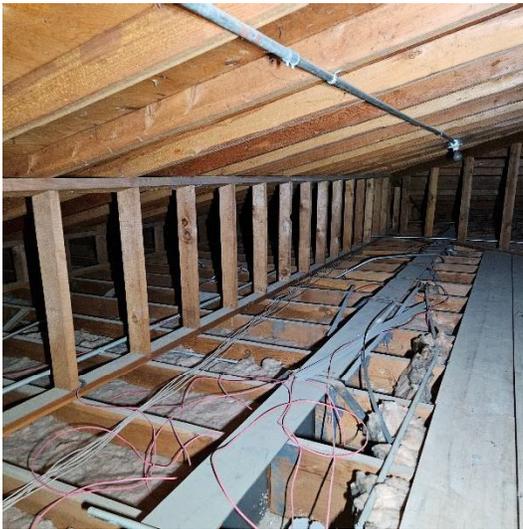
Wood rafters and supporting knee wall, with ceiling joists bearing on steel beam

- No structural deficiencies were noted during the walk-through survey of the roof and attic framing.

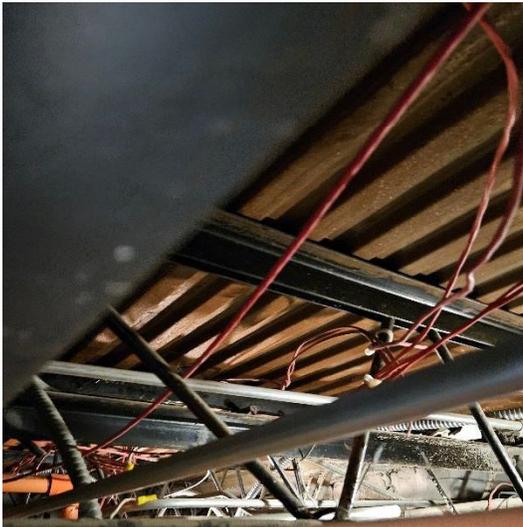
Surface corrosion on metal deck

- Surface corrosion on the underside of the metal floor deck at second floor framing.

- Ceiling finishes should be removed and localized areas of each floor to determine the extent of surface corrosion on the metal floor decks. Where the corrosion has progressed beyond a light surface patina, the steel should be cleaned and coated with (1) coat of a zinc-rich primer.

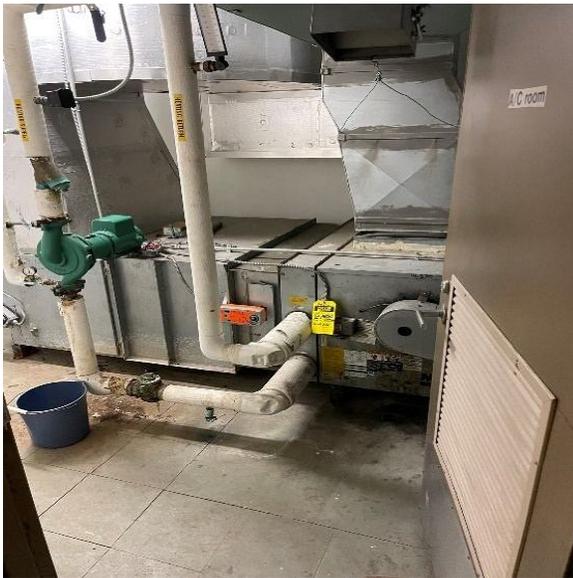
The building's central heating system consists of two natural gas boilers that send hot water out to varying types of equipment such as cabinet unit heaters, fan coils, fin tube radiation and (2) two air handling units. The boilers are approximately 1997 vintage and are rated at 900,000 BTU/HR each. The boilers and surrounding piping show signs of deterioration, mainly at fitting connection points. Hot water appears to have (5) five zones within the boiler room and circulation provided by a myriad of pump sizes/brands. The main line pumps are Baldor 3hp. The two remote air handlers appear to be 2006 based upon serial numbers, but no CFM data is available. Both units contain heating coils only with local pumps for circulation.

Air handler

In general, the visible systems are in fair condition and have serviceable life remaining. However, with most of the equipment approaching 20 years in use, replacement is recommended in the event of a future major building project.

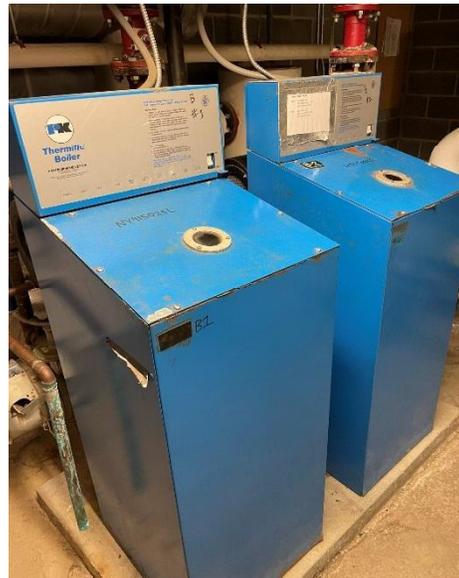
Boilers

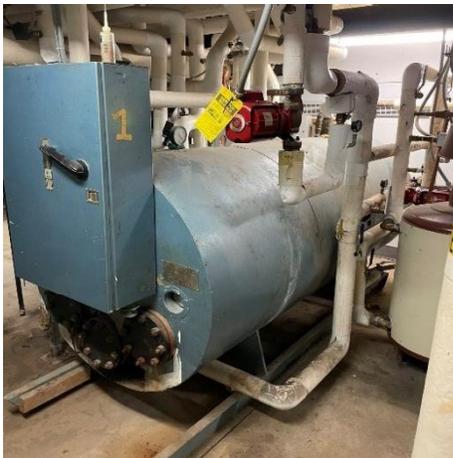
1966 Electric water heater

Based on the vintage and inefficiencies of the 1966 electric water heater, it would be beneficial to remove this component from the system. The 1999 vintage gas-fired water heaters are recommended for replacement.

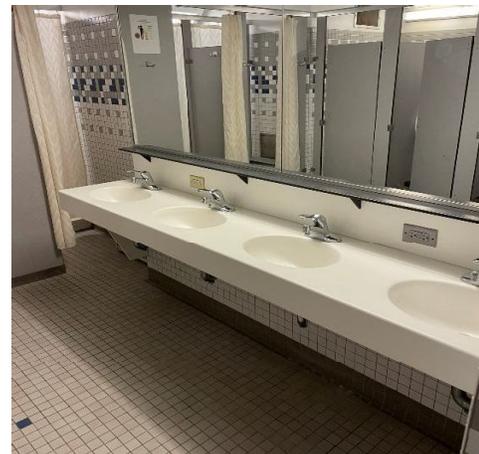
Sanitary waste is gravity-fed except for a multi-pump lift station with an alarm at the lowest levels of the building. The existing pumps and control panels appear to be in fair condition. The plumbing fixtures in general appear to be of similar vintages and in fair condition. While serviceable, they are approaching the end of their useful life and replacement should be considered in the event of a major project in the future.

Plumbing fixtures

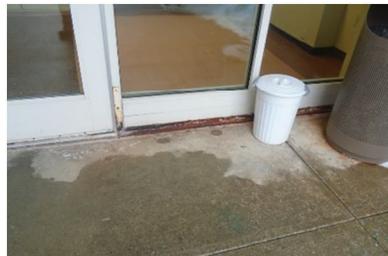
aluminum-framed windows remain in good condition and feature double-paned glazing. However, the aluminum exterior doors exhibit visible salt damage in some areas. Additionally, additional storm drains are needed at the bottom of the

Deterioration at bottom of window framing at sidewalk

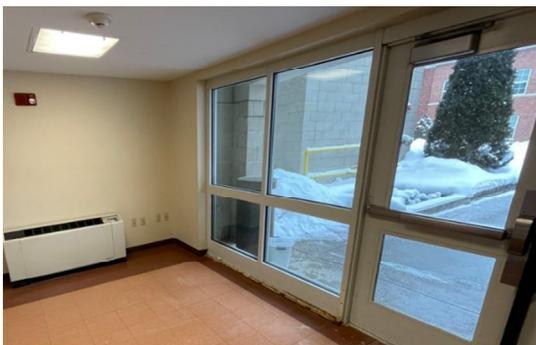
Deterioration noted at the bottom of the window framing

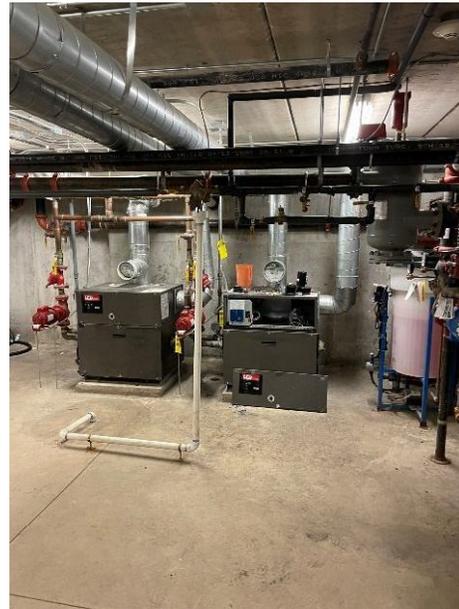
The building's central heating system consists of two natural gas boilers sending hot water out to a secondary heat pump system located throughout the building. The boilers are approximate 2006 vintage and are rated at 600,000 BTU/HR each. The boilers and surrounding piping appear to be in good condition. During the time of inspection, Boiler #1 was inoperable due to a minor mechanical failure. The facility has the replacement part on order. The primary hot water boiler loop circulation is provided by 1/2HP Bell & Gossett pumps, which also appear to be in relatively good condition and approximately same vintage as boilers. From there, the main hot water supply and return to the secondary heating devices are circulated by two Bell & Gossett 5HP base mounted pumps rated at 155gpm. The pumps and piping in the immediate area appear to be in good condition. The Boiler #1 flue has been partially replaced/repaired. This installation may warrant review for replacement.

Boilers

In general, the visible systems are in fair condition and have serviceable life remaining. However, with most of the equipment approaching 20 years in use, replacement should be considered as part of any upcoming project.

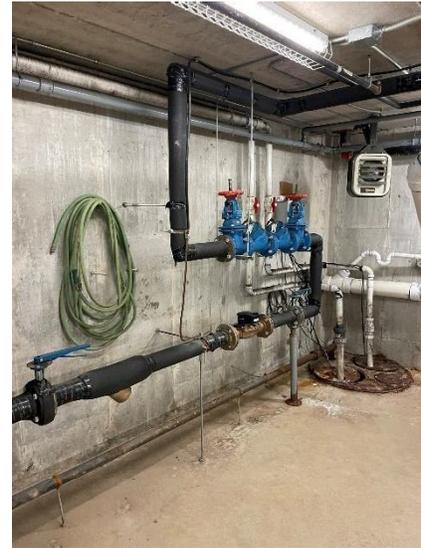
Domestic water service entrance

Domestic water piping within the boiler room with visible corrosion at joints and some devices such as balancing valves should be reviewed for replacement.

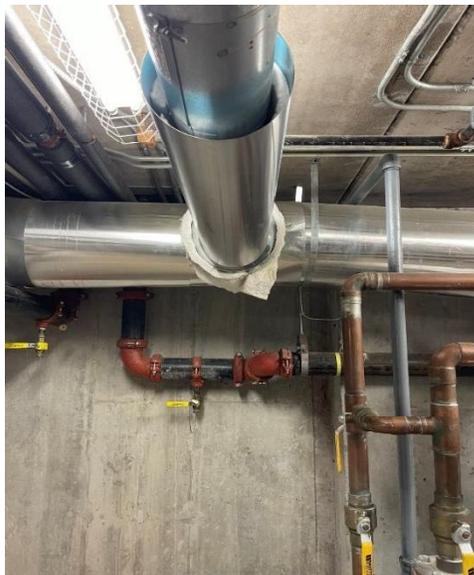
Boiler #1 flue

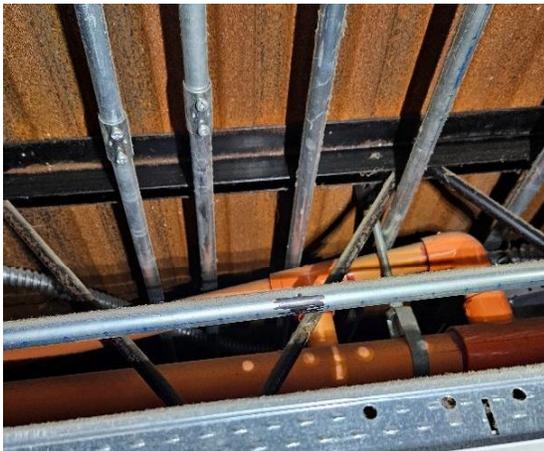
Surface corrosion on second-floor metal deck above first-floor lobby

- Extensive surface corrosion was noted at the second-floor metal deck above the first-floor lobby. This small area of the second-floor framing was the only visually accessible area; the full extent of the surface corrosion could not be verified.
- The exposed first-floor metal deck and open web steel floor joists at the east wing of the building were found to have extensive surface corrosion.
- Six (6) first-floor open web steel floor joists below the lobby and men's bathroom are severely corroded where they bear on an existing masonry foundation wall. The observed damage has potentially compromised the overall strength of the joist members.

- Ceiling finishes should be removed in localized areas below the first-, second- and third-floor framing to determine the extent of surface corrosion on the existing metal deck and open web steel floor joists. The surface corrosion should be removed and the members coated in one (1) coat of a zinc-rich primer.
- A structural investigation and analysis of the corroded first-floor deck and open web steel joists should be performed to determine if the structural capacity of the floor system has been compromised.
- The six (6) heavily corroded first-floor joists below the lobby and men's bathroom should be repaired or replaced, as determined by a structural engineer's assessment of the existing conditions.

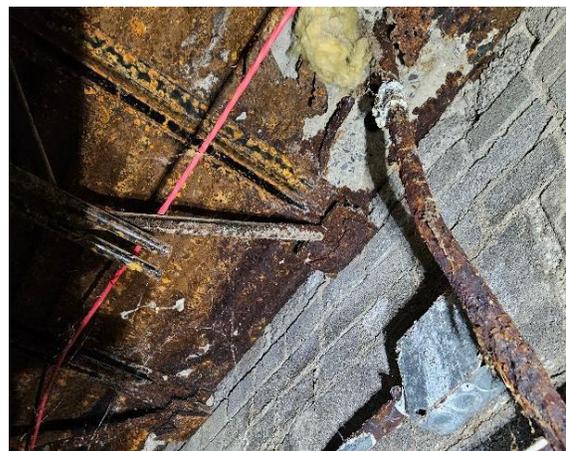
Heavily corroded first-floor joist at foundation wall bearing location

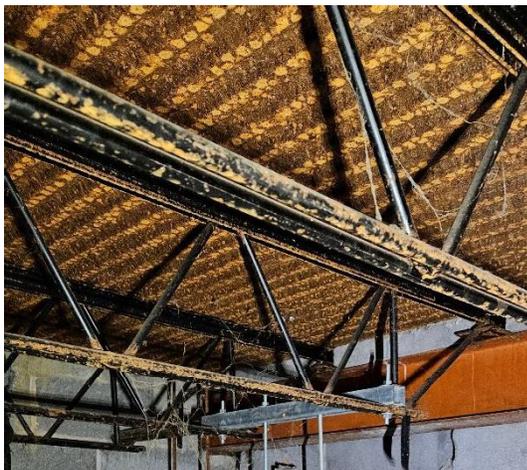
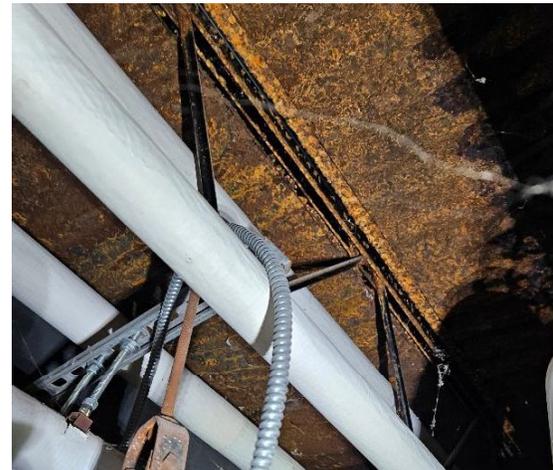
Extensive surface corrosion at first-floor deck and floor joists

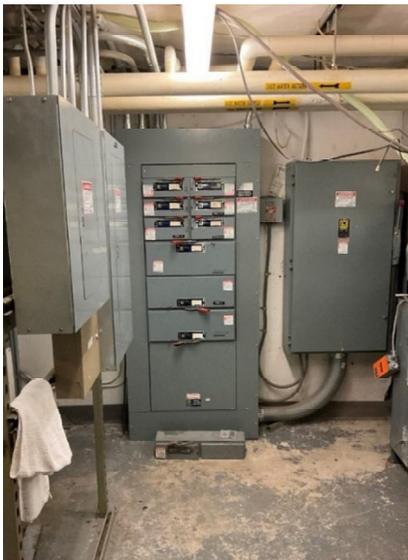
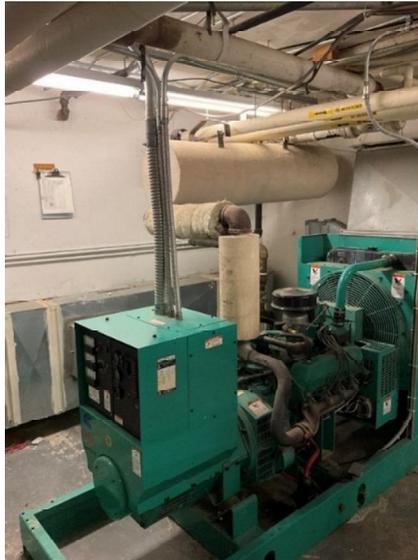
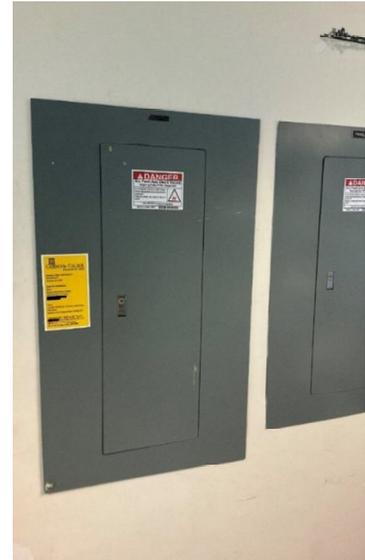
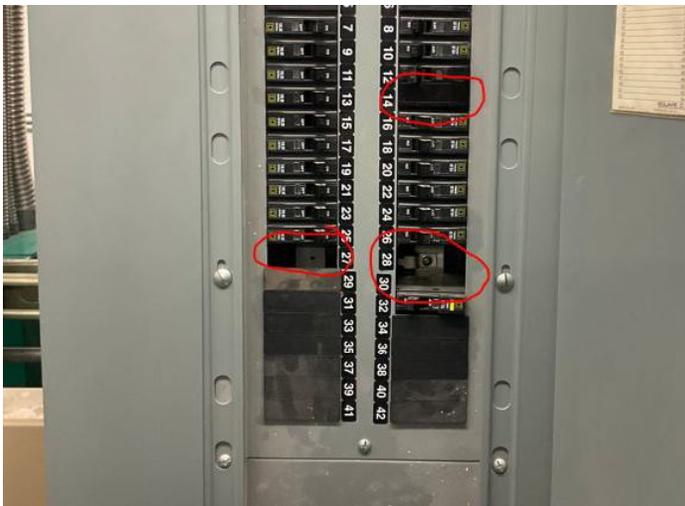
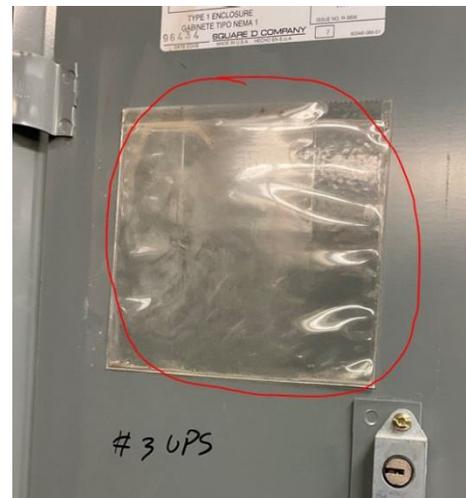
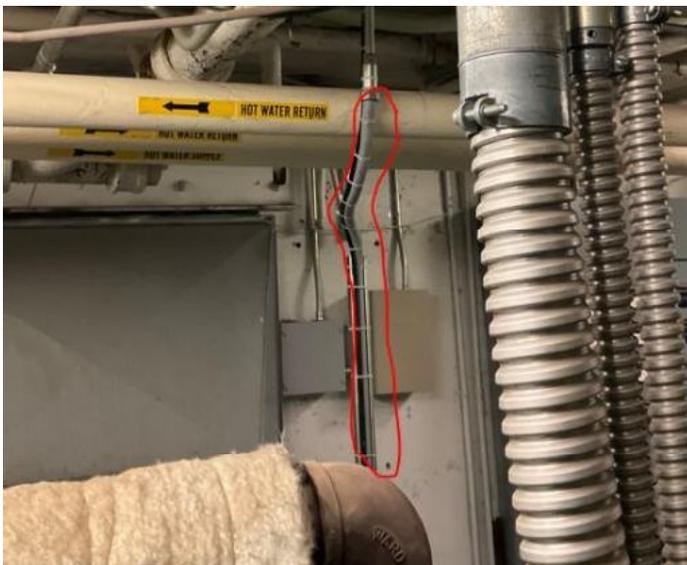
The electrical distribution system is made up of a number of distribution panelboards located in the electrical/utility room and throughout the building. The distribution equipment is of various sizes, ratings, and manufacturers. That said, most equipment is manufactured by Square D. It was observed that the distribution equipment, conduit, and wiring all appears to have been replaced during the 1990's renovations. All the equipment appears to be in satisfactory condition. It is noted that the typical useful life of distribution equipment like that installed around the building is 30 years.

As mentioned within the evaluation section above, most electrical distribution equipment appears to be from the 1990's renovation project. The equipment is nearing the end of its useful life, but everything appears to be in good overall condition. The only deficiencies noted during the site visit included missing circuit breaker filler plates in a panel, wires zip-tied to conduits, and a missing panel directory. Our recommendation is to correct these safety concerns/code violations.

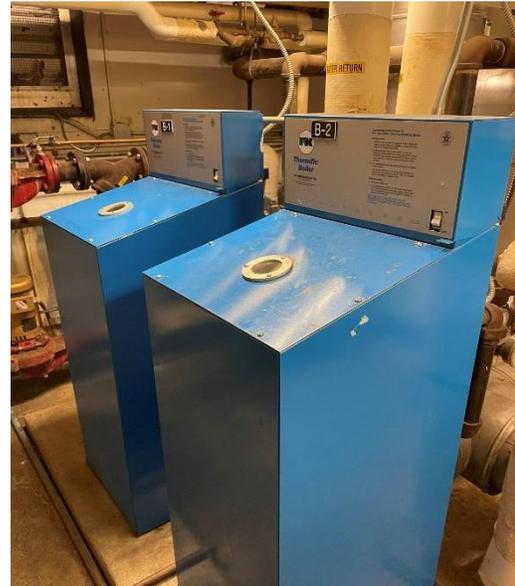
Boilers

The building's central heating system consists of two natural gas boilers that send hot water out to varying types of equipment such as cabinet unit heaters, fan coils, fin tube radiation and one (1) air handling unit. The boilers are approximately 1997 vintage and are rated at 900,000 BTU/HR each. The boilers and surrounding piping show signs of deterioration mainly at fitting connection points. Hot water appears to have several zones within the boiler room and circulation provided by a myriad of pump sizes/brands. One of the main boiler loop pumps is very noisy and should be replaced. The remote air handler appears to be 2006 based upon serial numbers, but no CFM data is available. This air handler is heating only. There was no central cooling equipment evident during inspection

In general, the visible systems are in fair condition and have serviceable life remaining. However, with most of the equipment approaching 20 years in use, replacement should be considered as part of any upcoming project. Other than the limited areas served by air handlers, there are little-to-no mechanical ventilation systems in place. If the planned usage of the building changes, a forced air mechanical system may need to be installed to meet current ventilation code requirements.

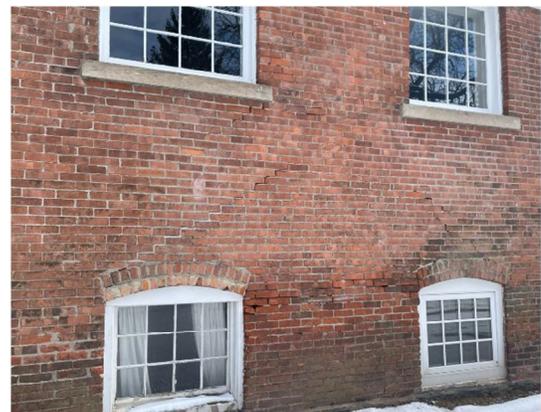
The brick masonry exterior is generally in poor condition and several areas need to be rebuilt. There is evidence of cracked and missing mortar joints, spalling brick, cracked brick, and efflorescence. The level of deterioration present and the duration of the exposure may have created additional, unseen damage that was not visible at the time of the review. The building has very large and detailed frieze board around the perimeter, which is in good condition. Preventative work to the roof and roof edge is recommended to prevent damage to these architecturally beautiful elements. At the time of the review, several very large pieces of ice weighing hundreds of pounds each were observed on the ground below the roof edge. A combination of the roof valleys and the large amount of heat loss through the roof has led to ice dam conditions that create these massive pieces of ice.

Step cracking and heavy deterioration on the brick

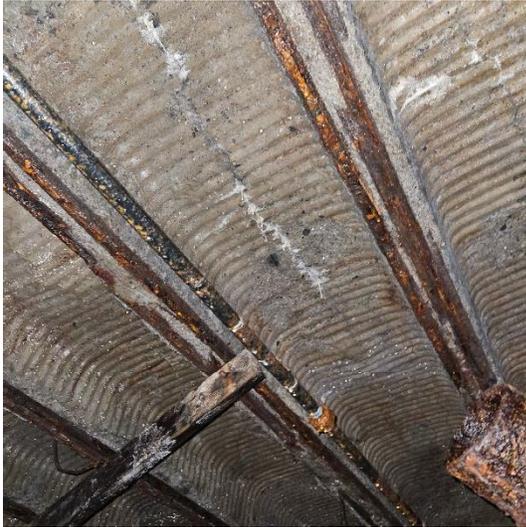
Corroded and damaged concrete ceiling above old coal bin

- The concrete ceiling above the old coal pit area of the building has significant concrete damage, exposing the reinforcing bars within the slab web members. Additionally, the exposed reinforcing bars are heavily corroded.

- The coal bin area should be infilled to protect against collapse of the existing ceiling framing. A new access point to the crawl space area below the building should also be constructed to replace the current access from the coal bin area.
