Cazenovia College Redevelopment Study

Completed 2025

MRB
Group

Village of
Cazenovia, NY

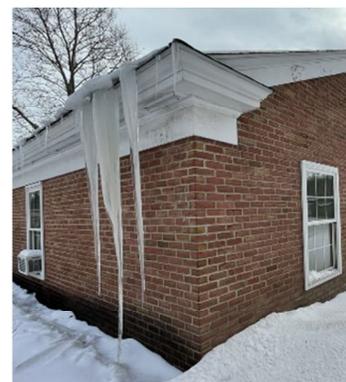
The brick masonry on the exterior of the Chapman Center Addition building is generally in good shape. Minor repointing is needed by mechanical door #10. The existing built-up wood frieze board is in good shape, despite minor peeling paint, but at risk of damage from severe ice damming. It is presumed that heat loss through the building's eaves and roof perimeter is the cause of the continuous ice damming. If not corrected, in addition to the damage to the exterior frieze, gutters, and roof edge, the building is at risk of water infiltration from the roof into the building envelope, leading to damage and mold. The original windows and doors have been replaced with vinyl windows and insulated steel doors, both of which are in good condition. The sloped roof was not fully visible due to the weather conditions and snow. Of the areas observed, the existing architectural shingles appeared to be in good shape.

Severe ice damming at eaves

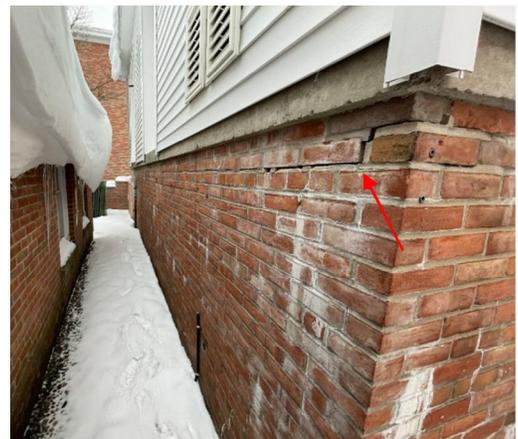
The exterior brick masonry at New Hubbard Hall is generally in good condition, with a few specific areas requiring attention. Around the perimeter of the walk-in cooler, multiple sections have cracked or missing bricks and deteriorating mortar joints. Efflorescence appears in several locations, indicating potential water infiltration and possible internal damage within the wall cavity. A more detailed investigation is recommended to identify the source of moisture and address the issue appropriately. Adjacent to the walk-in cooler, the kitchen loading dock is in poor condition. Installing new guardrails and truck dock bumpers is advised to improve safety and functionality. The exterior doors consist of insulated, painted metal doors and aluminum storefront doors.

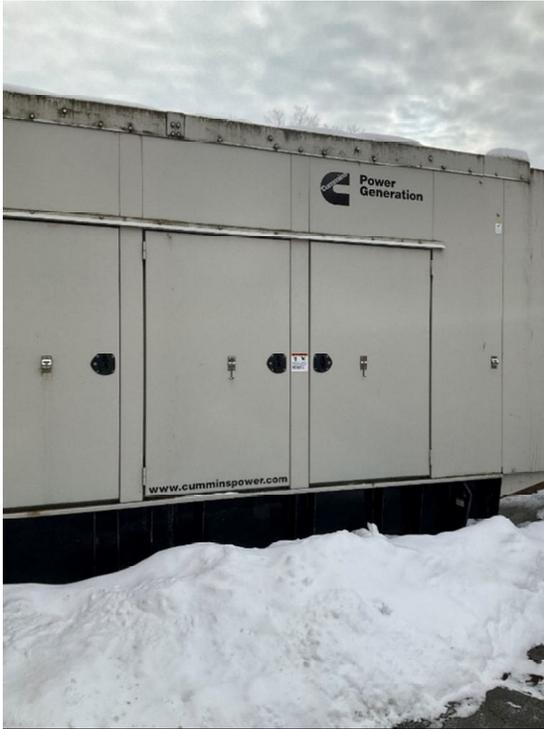
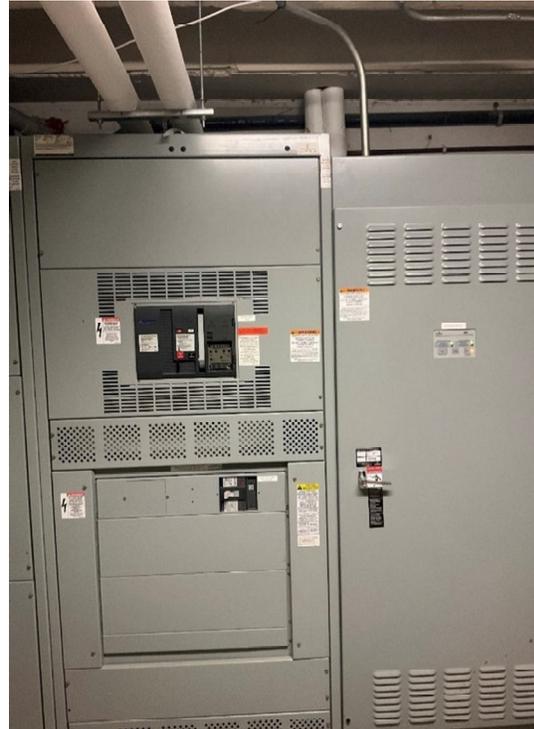
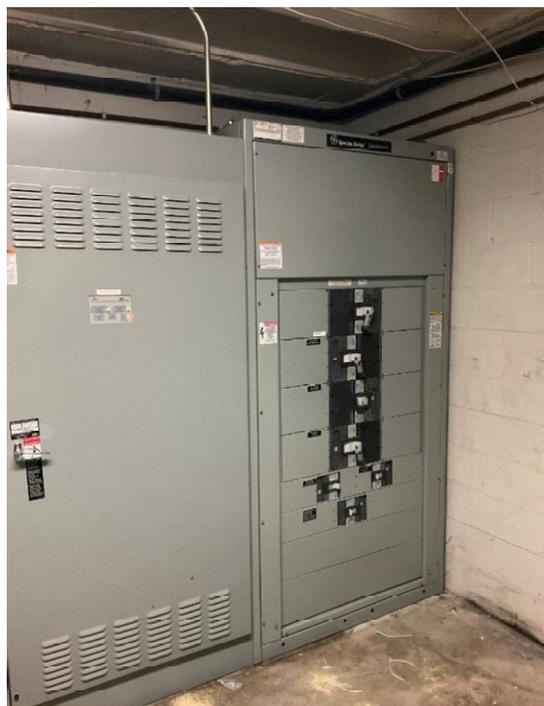
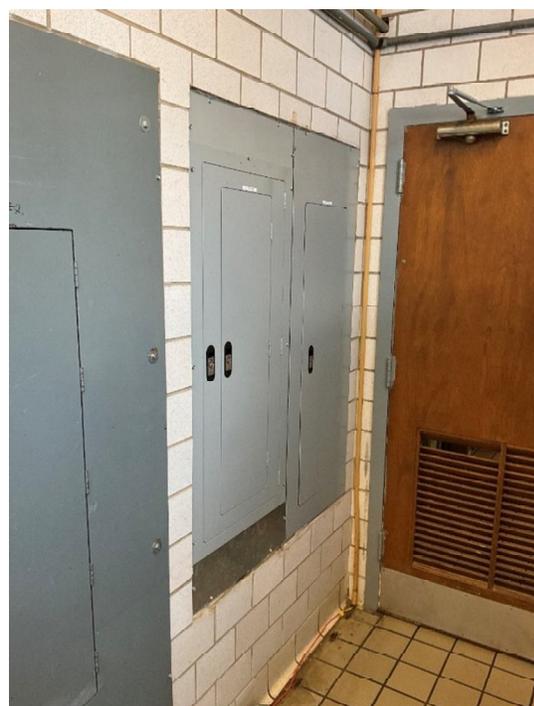
The electrical distribution system is made up of a number of distribution panelboards located in the electrical/utility room and throughout the building. The distribution equipment is of various sizes, ratings, and manufacturers. That said, most equipment is manufactured by GE. It was observed that the distribution equipment, some conduit, and some wiring appear to have been replaced during the 2000's renovations. Additionally, the distribution panels in the kitchen were replaced/retrofitted in 2020 with new Siemens panels and circuit breakers. cursory observations indicate that all electrical distribution equipment has not had industry-accepted preventative maintenance, which would provide a better understanding of the internal working conditions.

As mentioned within the evaluation section above, most electrical distribution equipment appears to be from the 2000's and 2020 renovation projects. The equipment has not reached the end of its useful life, and everything appears to be in good overall condition. The only deficiencies noted during the site visit included missing junction box knockouts, and inadequate working space in front of two (2) of the distribution panels. Our recommendation is to correct these safety concerns/code violations.

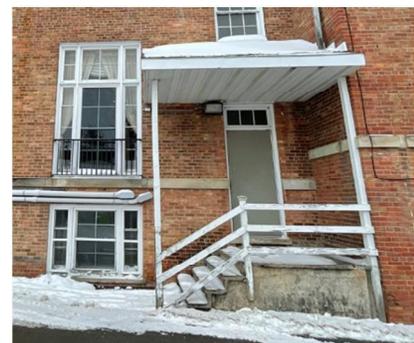
The concrete steps leading from the west side stairwell, along with the wood guards and roof, are deteriorating and should be replaced. The brick exterior is mostly in good shape, but there are a few problem areas. Efflorescence is visible on the outside corners of the roof pediment, indicating water infiltration and mineral deposits on the brick surface. Mortar deterioration has been observed at each main entrance door and along the driveway. Additionally, step cracking is present at various locations on the rear and east side of the building.

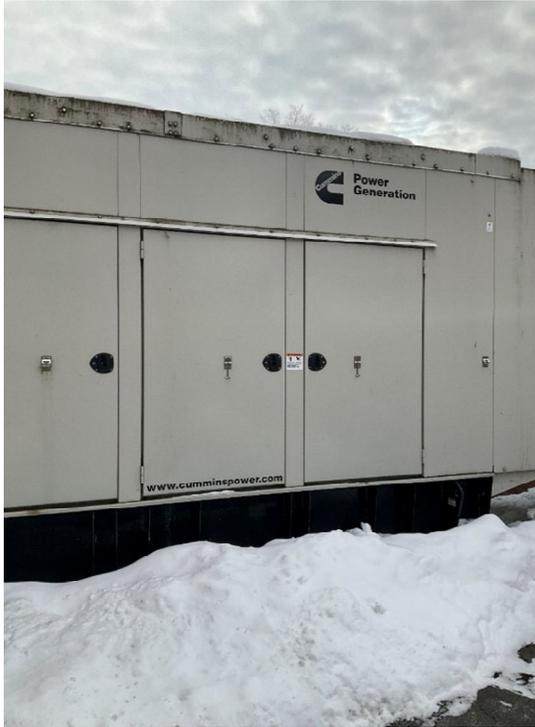
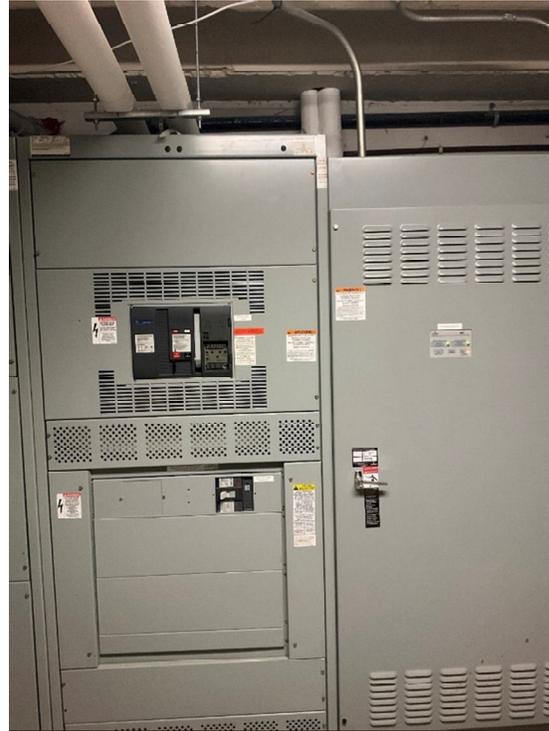
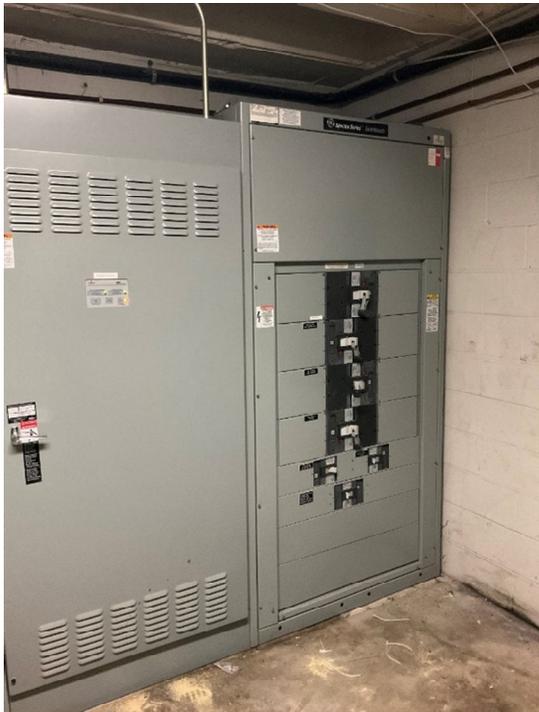
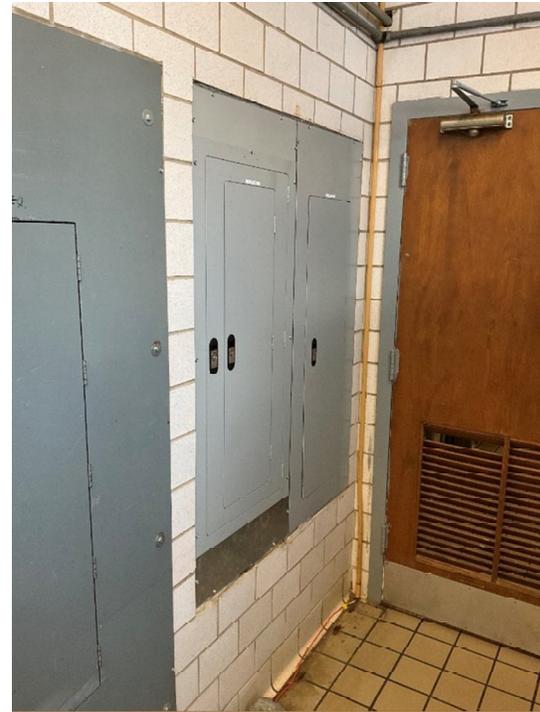
The electrical distribution system is made up of a number of distribution panelboards located in the electrical/utility room and throughout the building. The distribution equipment is of various sizes, ratings, and manufacturers. That said, most equipment is manufactured by GE. It was observed that the distribution equipment, some conduit, and some wiring appear to have been replaced during the 2000's renovations. Additionally, the distribution panels in the kitchen were replaced/retrofitted in 2020 with new Siemens panels and circuit breakers. cursory observations indicate that all electrical distribution equipment has not had industry-accepted preventative maintenance, which would provide a better understanding of the internal working conditions.

The equipment appears to date from a range of years between the 2000's and 2020 and is in satisfactory condition. It should be noted that the typical useful life of distribution equipment like that installed around the building is 30 years.

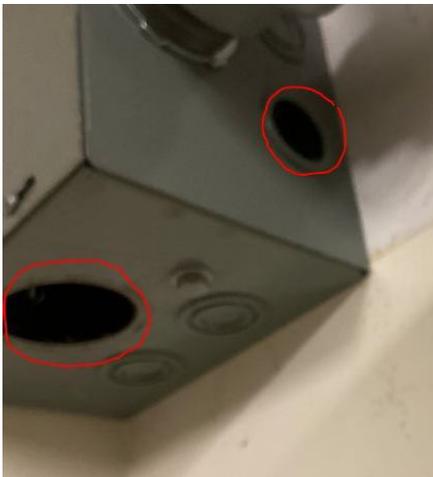
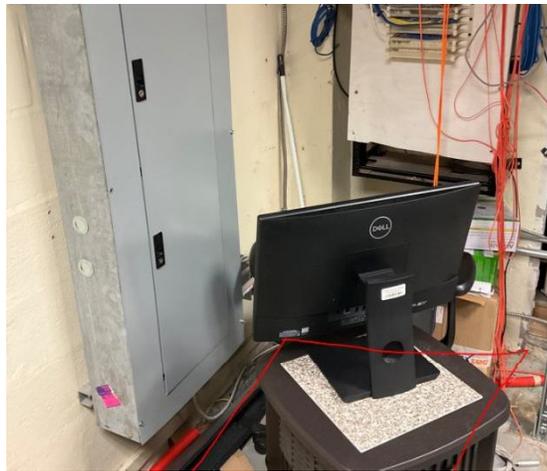
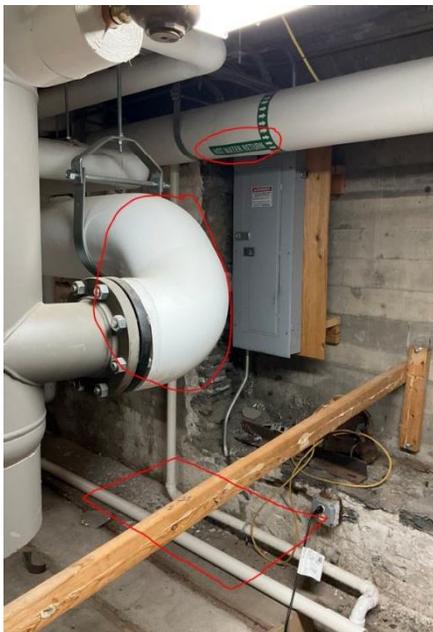
As mentioned within the evaluation section above, most electrical distribution equipment appears to be from the 2000's and 2020 renovation projects. The equipment has not reached the end of its useful life, and everything appears to be in good overall condition. The only deficiencies noted during the site visit included missing junction box knockouts, and inadequate working space in front of two (2) of the distribution panels. Our recommendation is to correct these safety concerns/code violations.

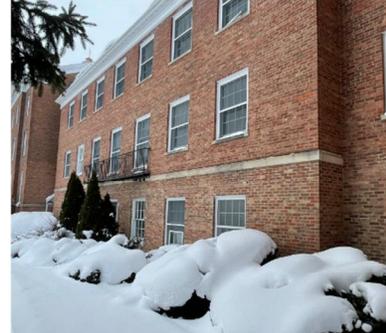
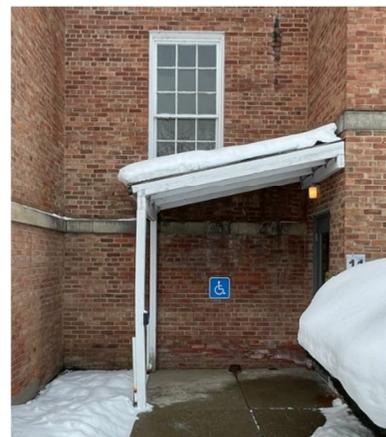
The brick masonry exterior is in good shape with only minor signs of deterioration. Salt has damaged the mortar in areas adjacent to building entrances. Repointing will be necessary at these locations to prevent water infiltration. Additionally, the shed roof that resides over this building entrance is starting to fail from water and ice falling on it. A new, more robust roof, preferably one that matches the building's characteristics, should be considered for its replacement.

The exterior windows appear to be original to the building. They are of wood construction with muntins creating true divided lites from single pane glazing. The wood trim and casing shows evidence of deterioration and peeling paint. The glazing putty that holds the individual panes of glass in place is failing, leading to air infiltration. Further deterioration is expected of the windows without repair or replacement. Due to weather conditions as the time of the building review, the team did not have access to review the existing sloped architecture shingled roof. The built-up frieze board around the roof perimeter is starting to show signs of deterioration from weather and sun exposure.

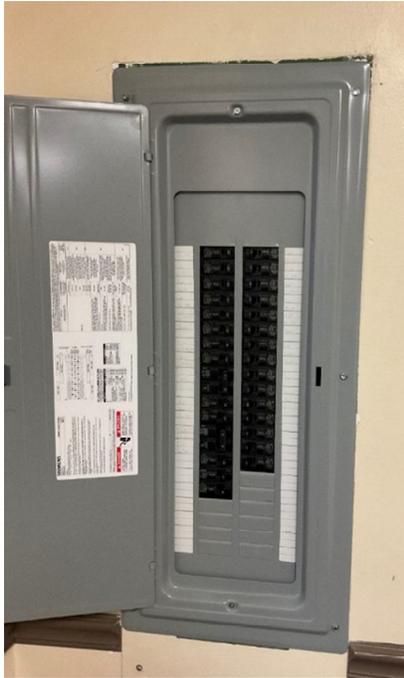
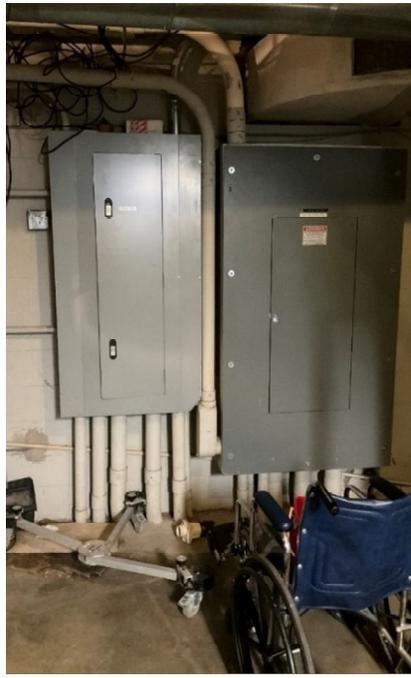
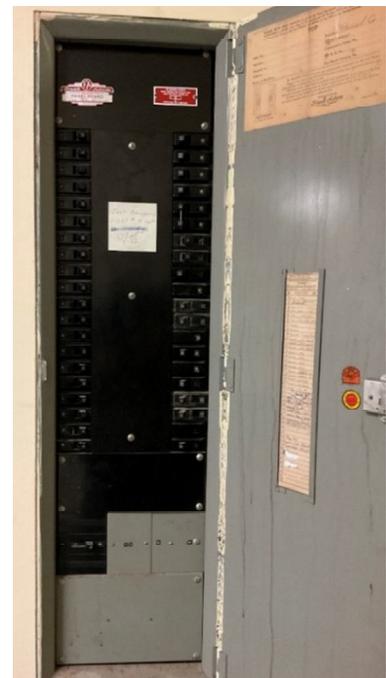
The electrical distribution system is made up of a number of distribution panelboards, located in the electrical/utility rooms and throughout the buildings. The distribution equipment is of various sizes, ratings, and manufacturers. Most of the panelboards were replaced in the early 2000's or in the 2020 renovation project. There were a number of older Frank Adam panelboards. The exact date of installation is unknown, but likely predates the 1980's. All the equipment from the early 2000's and the 2020 renovation project are in satisfactory condition. The equipment that predates the 1980's is well past its useful life. It should be noted that the typical useful life of distribution equipment like that installed around the building is 30 years.

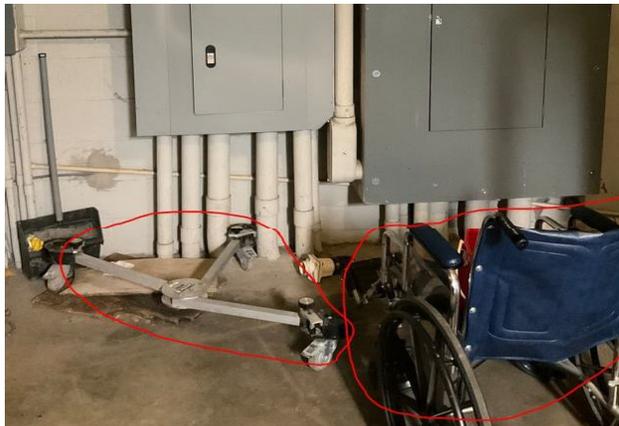
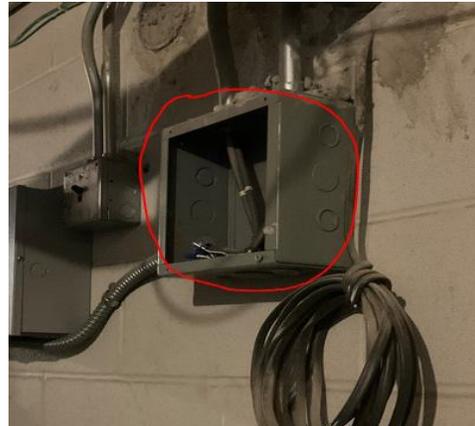
As mentioned within the evaluation section above, most electrical distribution equipment appears to be from the 2000's and 2020 renovation projects. This equipment is in overall good condition. The equipment that predates the 1980's has reached the end of its useful life, and while still functional, it should be considered for replacement. The only deficiencies noted during the site visit included missing junction box covers and inadequate working space in front of two (2) of the distribution panels. Our recommendation is to correct these safety concerns/code violations.

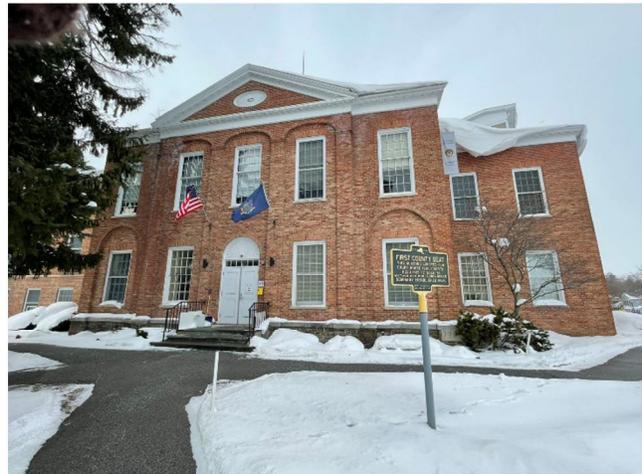
The brick masonry exterior is in good shape but with some evidence of water infiltration as evident from efflorescence below the outside corners of the front façade's roof pediment. The stone water table beneath the brick is in good condition but requires minor pointing at select joints. The exterior windows appear to be original to the building. They are of wood construction with muntins creating true divided lites from single pane glazing. The wood trim and casing is showing evidence of deterioration and peeling

paint. The glazing putty that holds the individual panes of glass in place is failing, leading to air infiltration. Further deterioration is expected of the windows without repair or replacement. The existing exterior doors are in fair shape with some deterioration at the bottom of the wood casing. Due to weather conditions at the time of the building review, the team did not have access to review the existing sloped architectural shingled roof up-close.

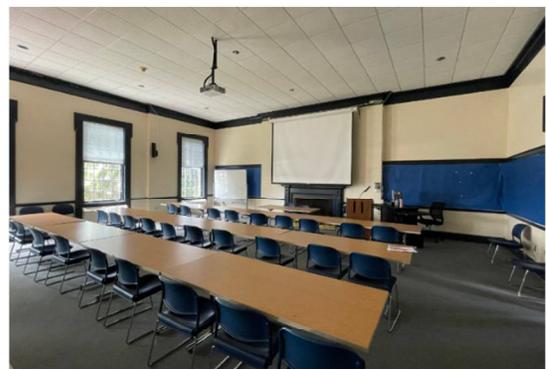
The third floor features painted plaster and lath walls, which are generally in good condition except for water damage in the lecture hall beneath a window. This floor includes a large lecture hall, a lounge, and a lobby. The flooring throughout is broadloom carpet, and the ceilings consist of suspended acoustic tiles. There is visible staining on the ceiling tiles in the elevator lobby, indicating a past water leak. Overall, the interior finishes are dated and at the end of their useful life.

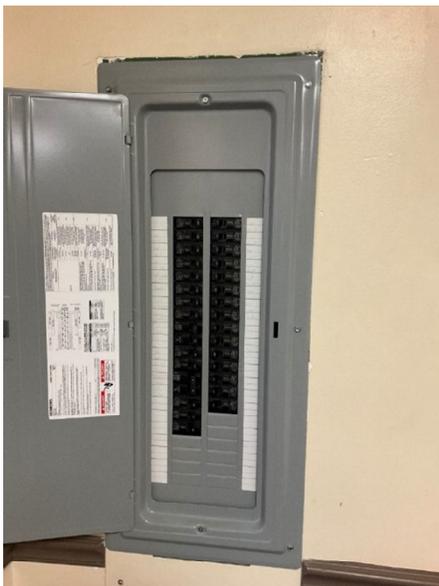
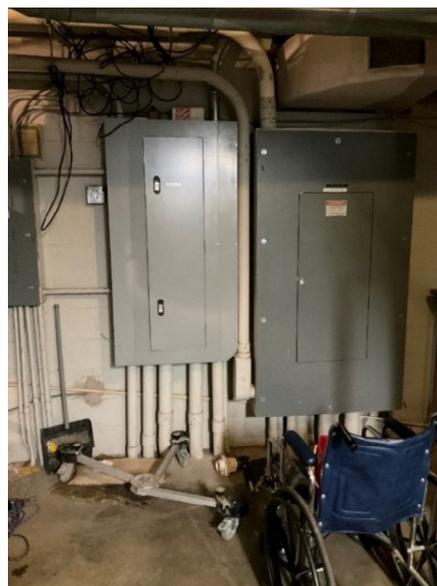
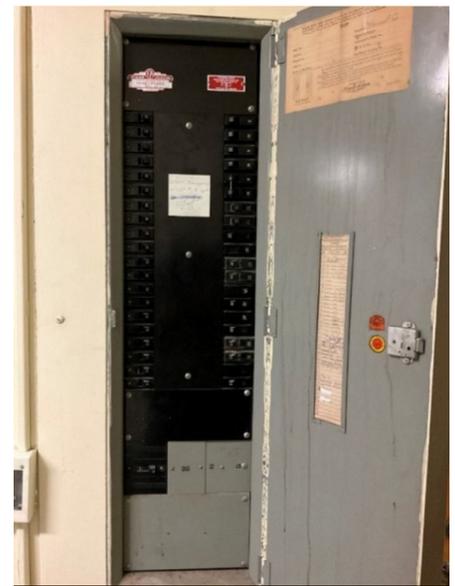
The electrical distribution system is made up of a number of distribution panelboards, located in the electrical/utility rooms and throughout the buildings. The distribution equipment is of various sizes, ratings, and manufacturers. Most of the panelboards were replaced in the early 2000's or in the 2020 renovation project. There were a number of older Frank Adam panelboards. The exact date of installation is unknown, but likely predates the 1980's. All the equipment from the early 2000's and the 2020 renovation project are in satisfactory condition. The equipment that predates the 1980's is well past its useful life. It should be noted that the typical useful life of distribution equipment like that installed around the building is 30 years.

As mentioned within the evaluation section above, most electrical distribution equipment appears to be from the 2000's and 2020 renovation projects. This equipment is in overall good condition. The equipment that predates the 1980's has reached the end of its useful life, and while still functional, it should be considered for replacement. The only deficiencies noted during the site visit included missing junction box covers and inadequate working space in front of two (2) of the distribution panels. Our recommendation is to correct these safety concerns/code violations.

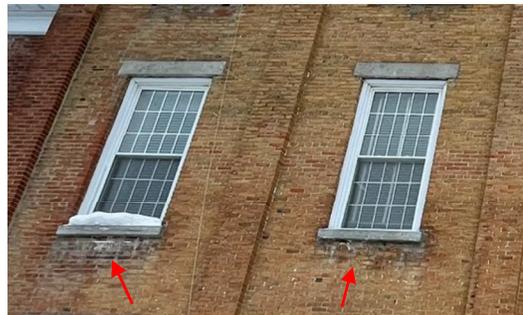
Williams Hall's exterior is constructed of two masonry materials: coursed rubble limestone and clay brick masonry. The brick façade is in fair condition, with several areas requiring repointing. Efflorescence was observed on the brick below more than half of the windowsills, along with damaged and missing mortar—an indication of water infiltration into the wall cavity. These areas should be addressed promptly to prevent further deterioration of the façade.

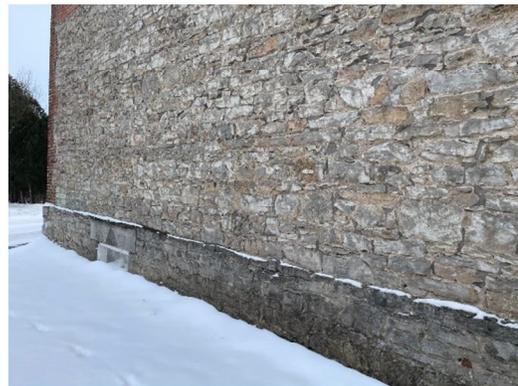
The limestone coursed rubble masonry is also in fair condition, though general inspection and repointing are recommended to prevent long-term deterioration. Several grade-level windows and window wells provide access to the basement level of Williams Hall. Deterioration in multiple window locations has led to openings in the building envelope, allowing water and pests to enter. Repairing these conditions is recommended to prevent further damage.

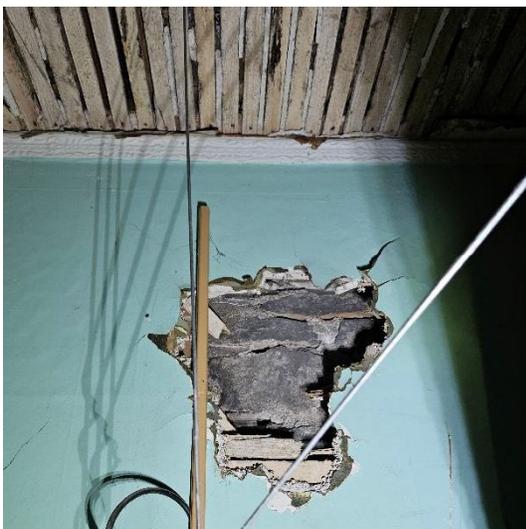
Third-floor ceiling and stone wall

- The third-floor framing should be investigated for any structural concerns related to the sloped floor and localized low spots.
- The unsuitable first-floor joist bearing condition should be repaired to provide adequate end bearing for the floor joists above the foundation wall opening.

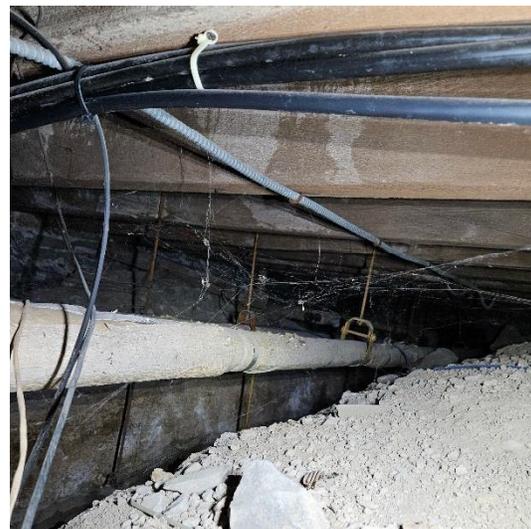
First-floor joists and dirt crawl space

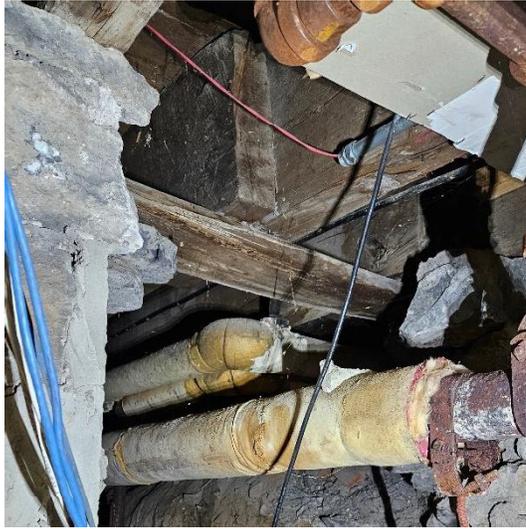
Unsupported first-floor joists

- During the field walkthrough, the third floor was noted to have a noticeable pitch. Localized low spots in the third floor were also encountered. Due to the existing finishes, the structure below could not be assessed to determine if the floor pitch and low spots were a structural concern, caused by long-term creep, or had another cause.
- A set of first-floor joists are not adequately supported at their bearing ends.
- Ongoing periodic water intrusion was visible at the northwest foundation wall of the building.

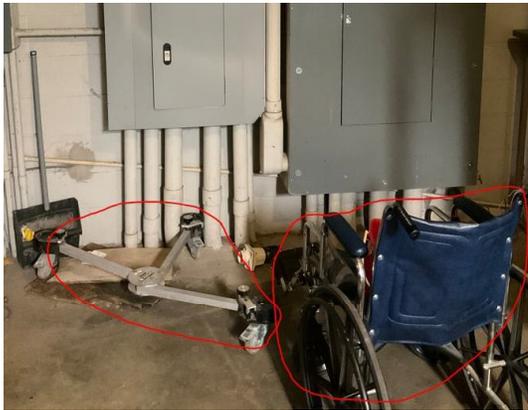
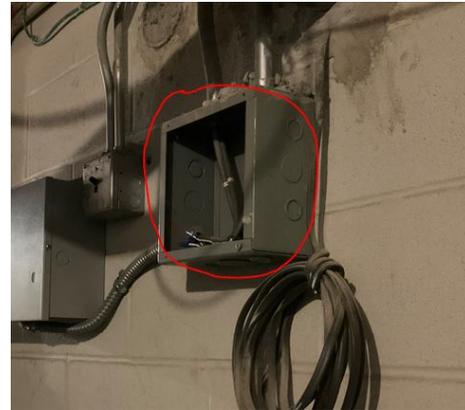
As mentioned within the evaluation section above, most electrical distribution equipment appears to be from the 2000's and 2020 renovation projects. This equipment is in overall good condition. The equipment that predates the 1980's has reached the end of its useful life, and while still functional, it should be considered for replacement. The only deficiencies noted during the site visit included missing junction box covers and inadequate working space in front of two (2) of the distribution panels. Our recommendation is to correct these safety concerns/code violations.

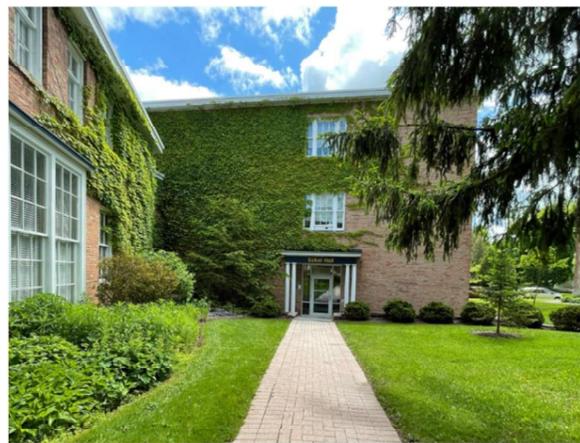
The brick masonry exterior is in excellent shape, with no signs of structural concerns or water infiltration. The climbing vine vegetation on the back of the building should be removed. While ivy and vegetation may enhance the collegiate aesthetic, the plant's tendrils adhere to the brick surface and can cause long-term damage to both the brick and mortar. The main roof, last replaced in 2014 is composed of a black EPDM with a 20 year warranty. The roofing membrane has 9 years of warranty remaining. An inspection is recommended when the warranty runs out to determine the next project cope. The greenhouse received a new PVC roof in 2009. No warranty was found noted in the existing documentation. Full replacement in the future is recommended. The exterior fixed and casement windows are double-paned insulated glass with aluminum frames. They appear in excellent shape, and even though they are approaching 30 years old, they still have many years of serviceable function. The exterior insulated aluminum storefront systems and fiberglass entrance doors are also in good condition with minor salt damage from being installed at grade.

Building Entrance and destructive building ivy

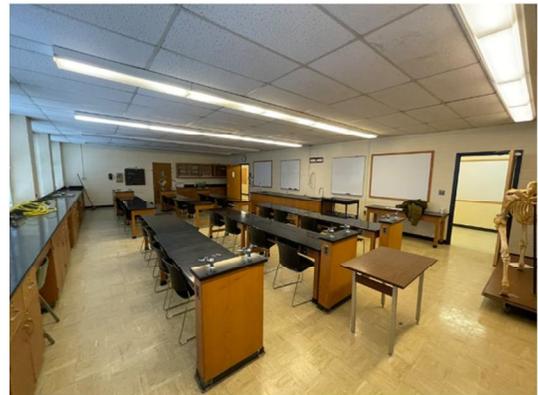
On the second floor, the building houses two large science laboratory classrooms, one smaller lab classroom, classroom storage, and toilet rooms with painted CMU walls. Flooring materials vary, with 9x9 vinyl tile—suspected to contain asbestos—found in one large laboratory classroom, the small lab classroom, a small storage room, the corridor, and the stairwells. The other large science lab classroom has 12x12 vinyl tile flooring, while the toilet rooms have ceramic floor tiles. The ceilings consist of 2x4 suspended mineral fiber acoustic panels, which are beginning to sag slightly, possibly due to high humidity. The interior doors are solid wood with spherical hardware, which does not meet accessibility requirements; replacing them with lever-style handles is recommended. Stairwell doors are fire-rated metal with accessible lever-style handles.

Science Classroom with suspect vinyl asbestos tile

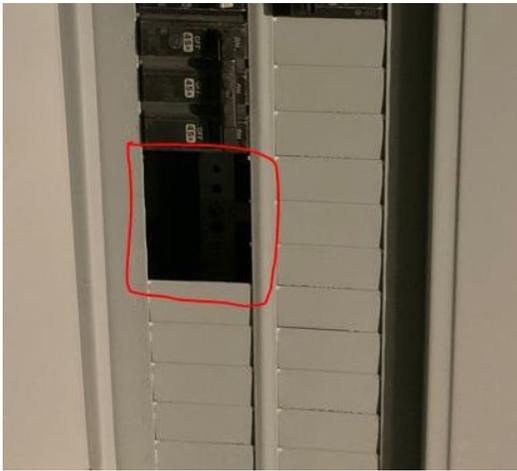
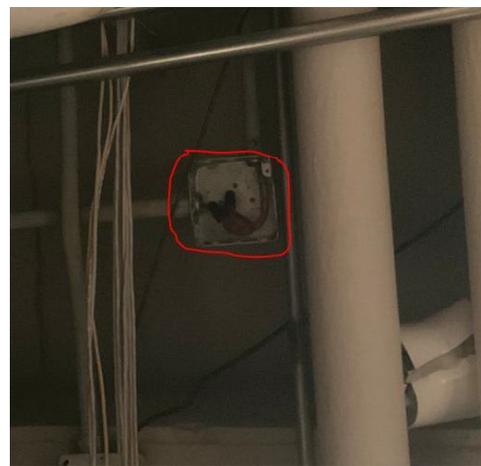
As mentioned within the evaluation section above most electrical distribution equipment appears to be from the 1990's renovation project. This equipment has reached the end of its useful life but appears to be in good overall condition. The equipment that is original to the buildings (switchboards and panelboards) has reached the end of its useful life. This equipment should be considered for replacement. The only deficiencies noted during the site visit included missing circuit breaker filler plates in a panel, wires zip tied to conduits, and missing junction box covers. Our recommendation is to correct these safety concerns/code violations.

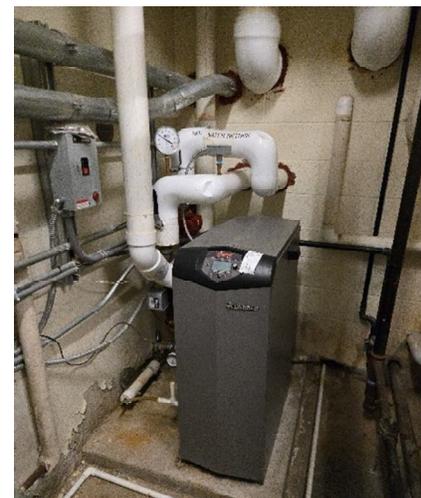
Boiler

The buildings central heating system consists of one natural gas boiler sending hot water out to various equipment such as fan coil units, cabinet unit heaters, cabinet unit ventilators, and air handler. The boiler is approximately 2014 vintage and is rated at 399,000 BTU/HR. The boilers and surrounding piping appear to be in good condition. All locally related pumps, controls and disconnects are of same vintage as boiler. It is noted that this boiler is actually within the footprint of the Library building.

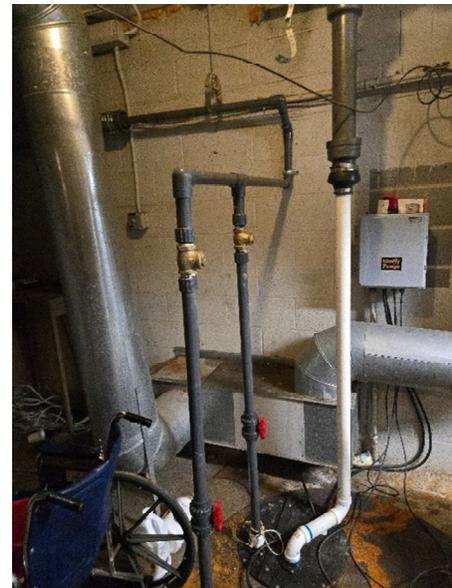
Sanitary waste is for the most part gravity fed except for a lift station for the lowest levels of the building. Lift station is a multi-pump system with a local alarm. Pumps and control panel appear to have been replaced in the last five years.

Updated lift station

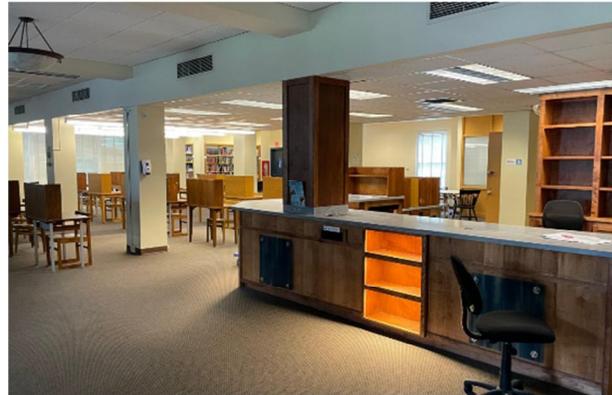
First Floor / Circulation Desk

Minor accessibility improvements are required throughout the building. It is recommended that the library circulation desk should incorporate a lower transaction area (30") and the toilet rooms would benefit from the addition of grab bars and lowered soap and paper towel dispensers. Due to the arrangement of existing interior partitions, not all doors meet accessibility guidelines and are not able to be amended without substantial renovation.

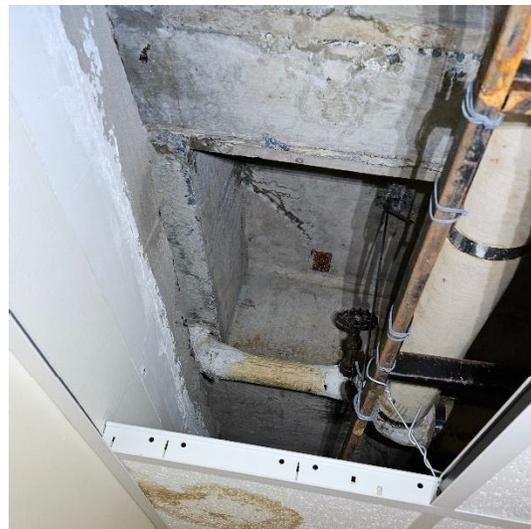
- Water-stained ceiling tiles were found in the archives room of the basement, at the southeast corner of the building.

Concrete slab behind ceiling tiles

- Where the framing could be visually observed, no significant areas requiring repairs or replacement were found. The water-stained ceiling tiles were dry to the touch, but this area should be monitored for signs of water infiltration

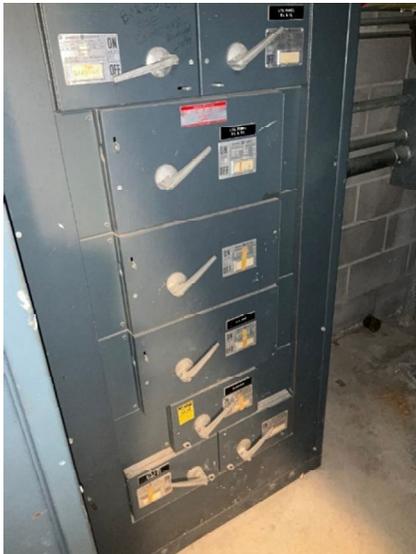
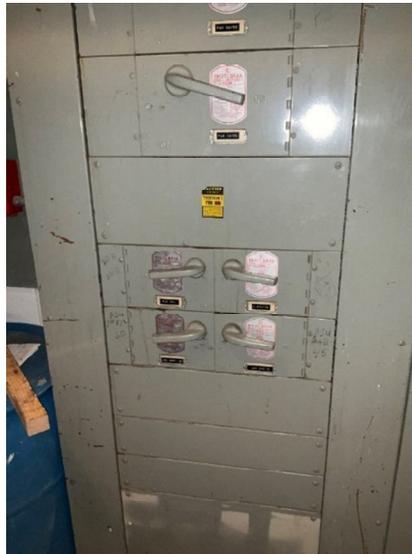
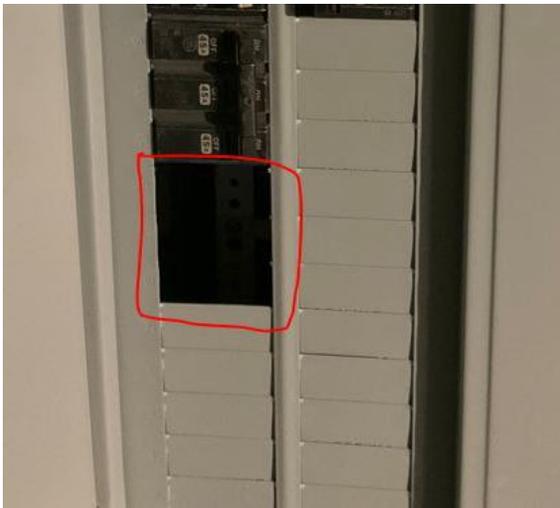
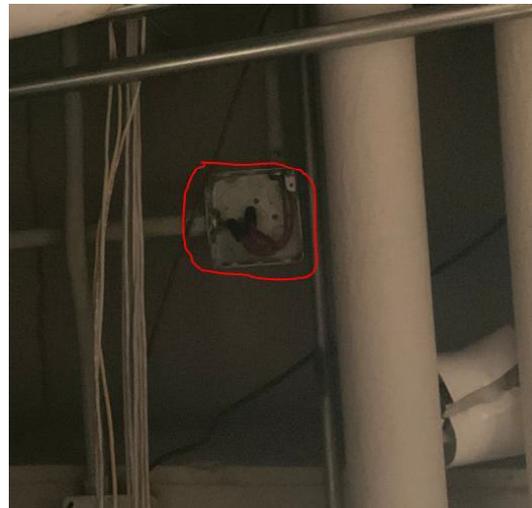
The electrical distribution system is made up of a number of distribution panelboards, located in the electrical/utility room and throughout the building. The distribution equipment is of various sizes, ratings, and manufacturers. It was observed that a number of the panels were replaced during the 1990's renovation project. There were also a number of panels that appeared to be original to the facility. All the equipment that was replaced during the 1990's renovation appears to be in satisfactory condition. The equipment that is original to the buildings is past its useful life. Note, typical useful life of distribution equipment like that installed around the building is 30 years.

As mentioned within the evaluation section above most electrical distribution equipment appears to be from the 1990's renovation project. This equipment has reached the end of its useful life but appears to be in good overall condition. The equipment that is original to the buildings (switchboards and panelboards) has reached the end of its useful life. This equipment should be considered for replacement. The only deficiencies noted during the site visit included missing circuit breaker filler plates in a panel, wires zip tied to conduits, and missing junction box covers. Our recommendation is to correct these safety concerns/code violations.

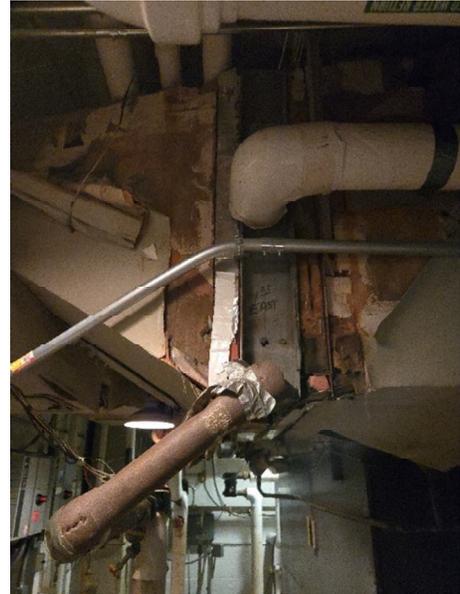
The cooling system is supported by an exterior pad mounted Daikin model cooling tower that supplies chilled water to the existing air handling system located within the basement. Based on serial number the vintage of the cooling tower is 2013. The air handlers supply cooling only during the summer months. The heating coils are no longer in use/connected. The extent of conditioned air within the building is unknown. The main base mounted pumps for chilled water are also in the basement and consist of two 7.5HP Marathon pumps. The AHU's are at the end of their useful lives.

Abandoned hot water coil at air handler

The current air handlers/fans distributing cool air to the larger gathering spaces are at the end of their useful lives. These systems should be reviewed further for replacement.

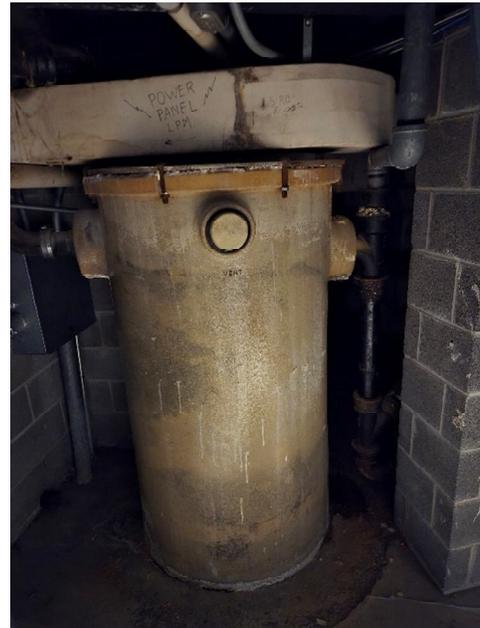
Sanitary waste is for the most part gravity fed except for a lift station for the lowest levels of the building. Lift station is a multi-pump system with a local alarm. Pumps and control panel are at the end of their useful lives. It is noted that there is glass waste piping down to a large acid waste type sump in the basement, likely servicing the lab areas.

Lab waste collection sump

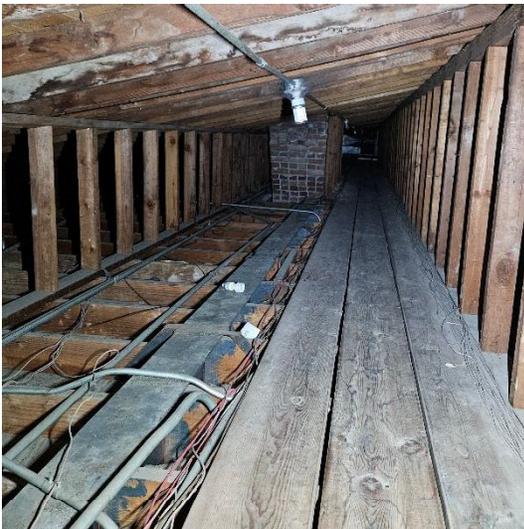
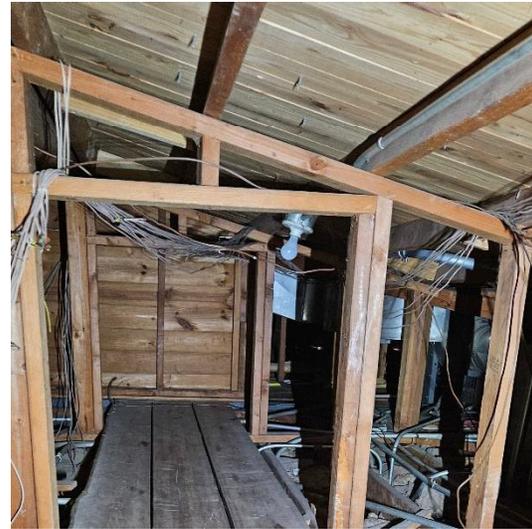
Wood rafters and supporting knee wall

Steel beams and column

- No structural deficiencies were noted during the walk-through survey of the roof and attic framing.

- Where the framing could be visually observed, no significant areas requiring repairs or replacement were found.

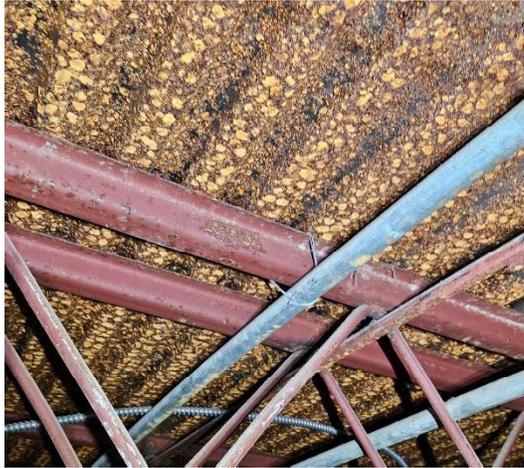
Corrosion at 2nd floor metal deck

- Where exposed to view, the underside of the 1st and 2nd floor metal decks is covered in a layer of surface corrosion.

- 1st, 2nd, and 3rd floor ceiling finishes should be removed to perform a full structural assessment of the existing metal deck to determine the extent and severity of the noted corrosion. At a minimum, the surface rust on the metal deck (and any open web steel joists) should be cleaned and a protective coating of zinc-rich paint should be applied to the cleaned metal surfaces to protect against future corrosion damage.
- The structural assessment may uncover localized areas of the metal deck and steel joist floor system that have progressed to a point where reinforcement and/or replacement is necessary, though this was not encountered during the field walkthrough.

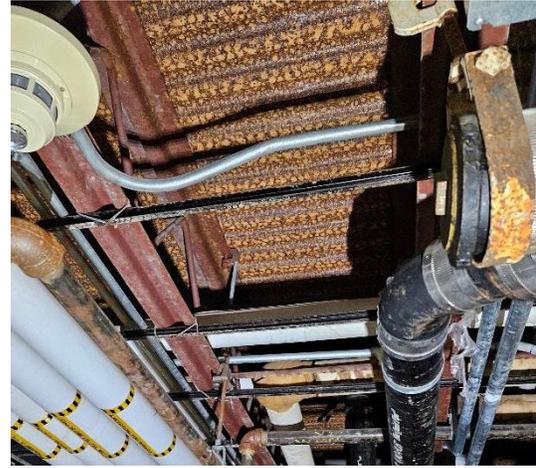
Corrosion at 1st floor metal deck

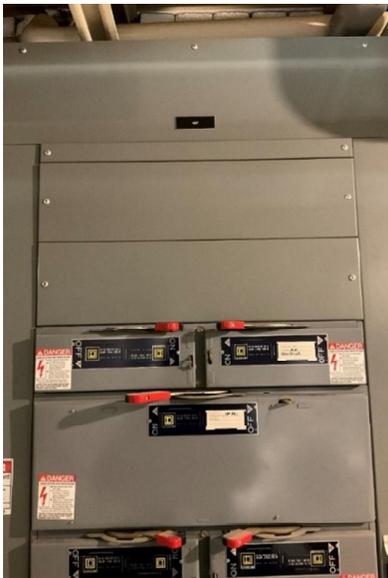
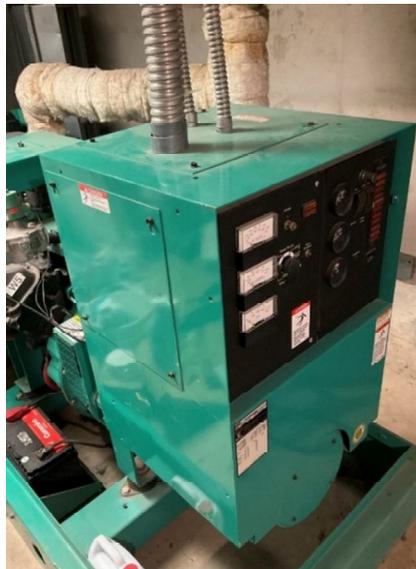
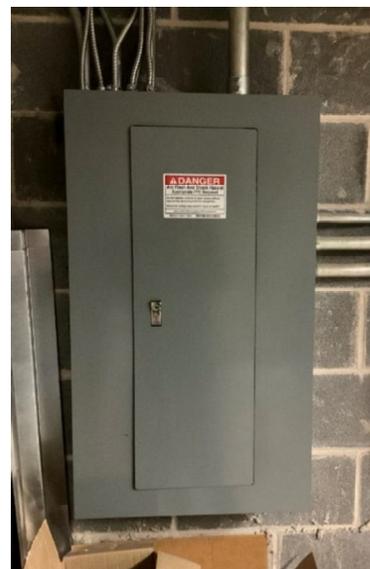
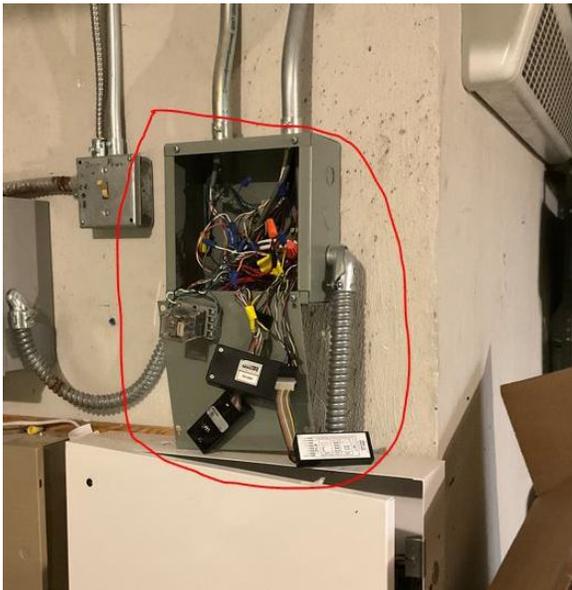
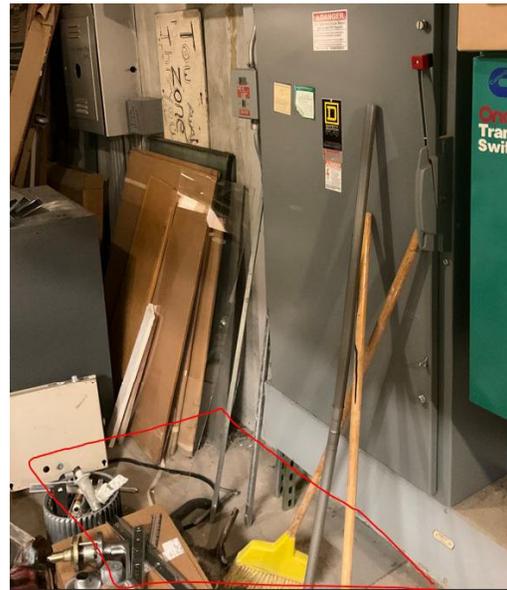
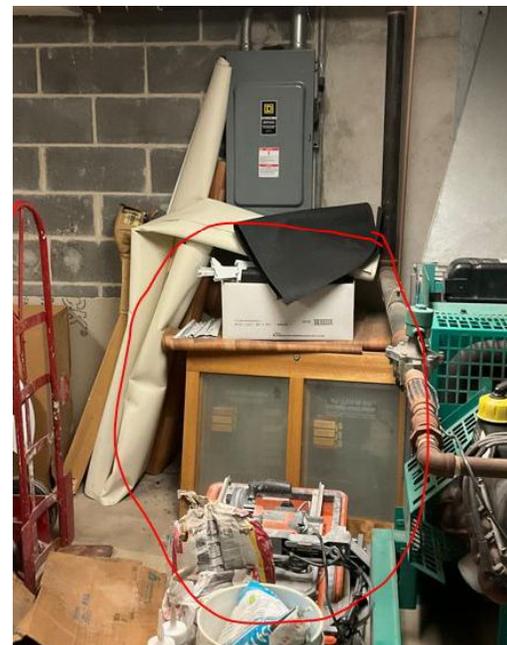
The electrical distribution system is made up of a number of distribution panelboards, located in the electrical/utility room and throughout the building. The distribution equipment is of various sizes, ratings, and manufacturers. That said, most equipment is as manufactured by Square D. It was observed that the distribution equipment, conduit, and wiring all appears to have been replaced during the 1990's renovations. All the equipment appears to be in satisfactory condition. Note, typical useful life of distribution equipment like that installed around the building is 30 years.

As mentioned within the evaluation section above most electrical distribution equipment appears to be from the 1990's renovation project. The equipment has reached the end of its useful life, but everything appears to be in good overall condition. The only deficiencies noted during the site visit included missing junction box covers and inadequate working space in front of two (2) of the disconnect switches. Our recommendation is to correct these safety concerns/code violations.

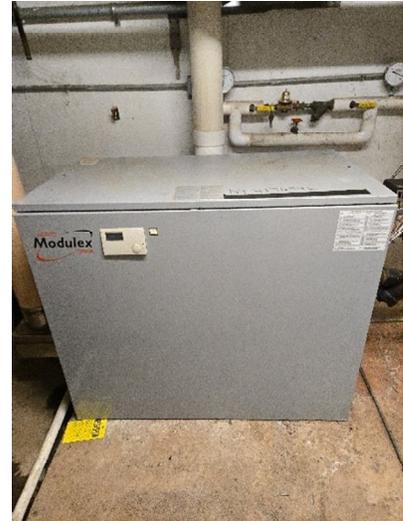
The buildings central heating system consists of one natural gas boiler sending hot water out to varying types of equipment such as cabinet unit heaters, fan coils, fin tube radiation and one air handler. The boiler is approximately 2010 vintage and is rated at 1,060,000 BTU/HR. While the boiler and primary boiler loop has significant useful life remaining many of the surrounding components such as piping, piping specialties, and some of the pumps are in relatively poor condition with moderate corrosion present. It is noted that one of the secondary heating loop pump motors has been replaced and date recorded is 1/3/25. Remote air handler appears to be 2006 vintage with heating capacity only.

Boiler

Main boiler system has useful life remaining. However, the surrounding mechanical piping system and many of its components have considerable corrosion. A more detailed inspection could be utilized to determine what components should be replaced.

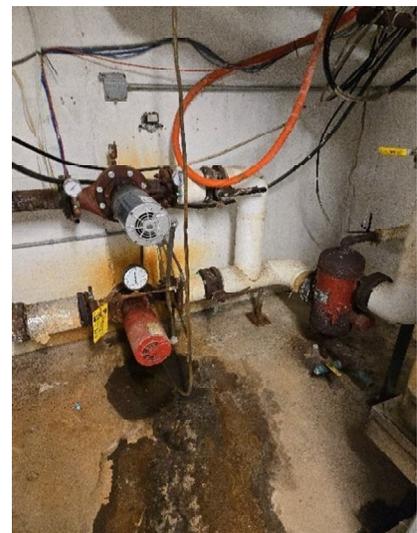
Heating system corrosion

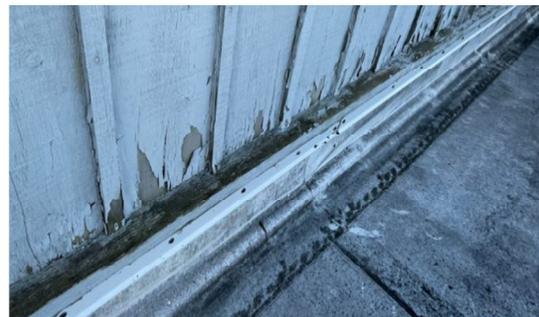
Deteriorated wood board and batten

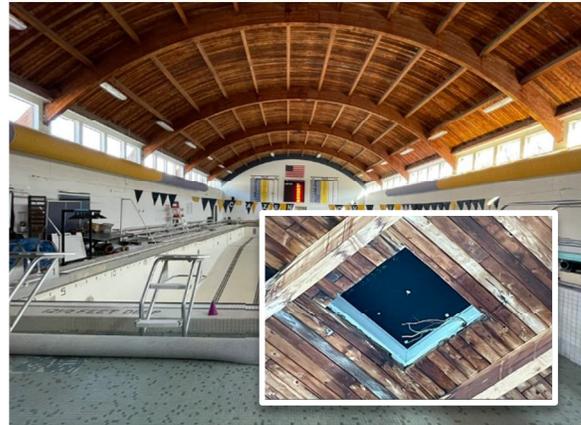
The barrel roofs are finished with white single-ply membranes, which show minor signs of age and wear. Evidence of past water infiltration was identified on the interior wood plank ceilings of the pool and gymnasium adjacent to smoke hatch openings. Further investigation and repair of these conditions is recommended to prevent future deterioration.

Indoor pool with barrel roof.
