Cazenovia College Redevelopment Study

Completed 2025

MRB
Group

Village of
Cazenovia, NY

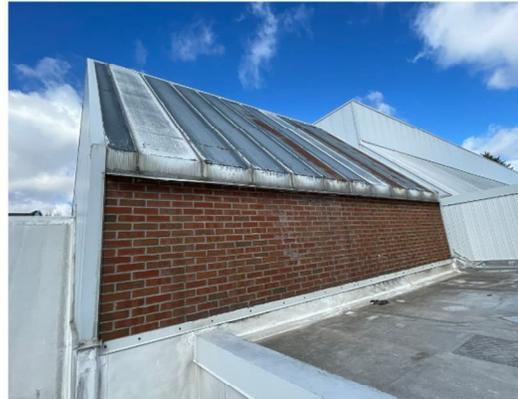
At the intersection between the old and new structures, standing seam metal roof accents are beginning to show finish failure. These panels will require cleaning, refinishing, and sealing to extend their useful life and maintain aesthetic continuity between the buildings.

Deteriorated standing seam roofing

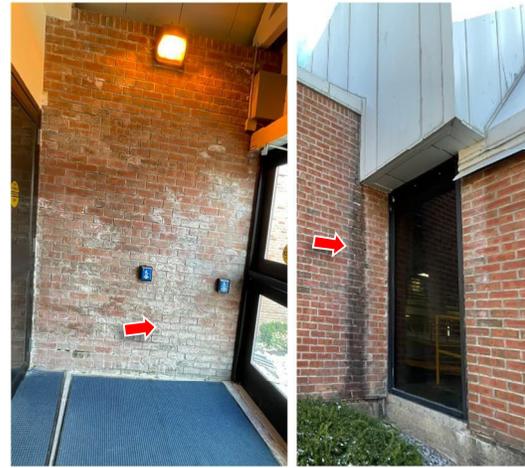
The brick masonry on the north side entrance of the building is deteriorating from weather exposure and more severely at one area experiencing heavy roof runoff. The water from the roof is sheeting down the brick façade and saturating the entire wall assembly. Evidence of water infiltration at this point can also be seen on the interior facing side of the building. Efflorescence is seen on the brick surface and internal damage to steel reinforcement is likely.

Water infiltration and brick efflorescence caused by roof water shed.

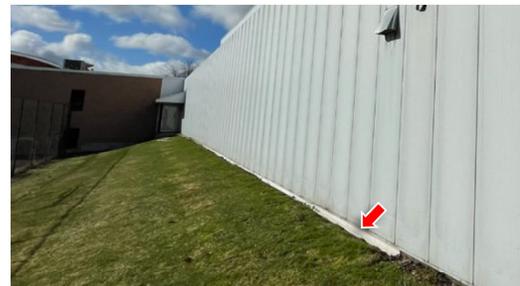
On the east side of the 1990 building addition, there is an ad hoc perimeter drain fashioned out of a roof gutter. More permanent corrective drainage solutions are recommended to channel rainwater away from building perimeter foundation.

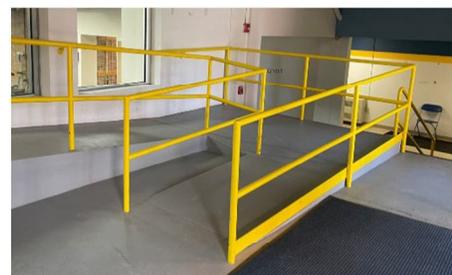
The interior environment in the 1990 building addition is similar to the existing facility but in better condition and with exposed roof structure. The addition is accessed through the main corridor and up an accessible ramp or stairs. Improvements to the railings are recommended to meet the current accessibility guidelines. The fitness room was observed to have rubber and carpet flooring and is overall in good condition.

Improvements to railings recommended

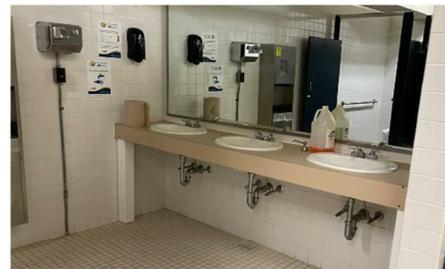
The building overall requires only minor upgrades in terms of accessibility. Most of the accessible toilet rooms require grab bars, plumbing trap guards, and soap/paper towel dispensers lowered. The rooms appear to have adequate clearance maneuvering space so modification costs would be minimal. The building is equipped with both an elevator and a lift, where appropriate.

P-trap protection required, add lever type faucets, lower soap dispensers

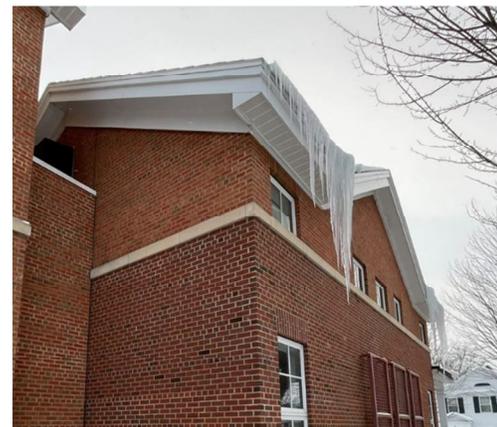
Some areas on the building's exterior show signs of water damming at the roof eave edge, likely caused by building heat loss. Large icicles have been formed, which can damage the building envelope and pose a safety hazard for pedestrians.

Ice damming condition on north façade (middle)

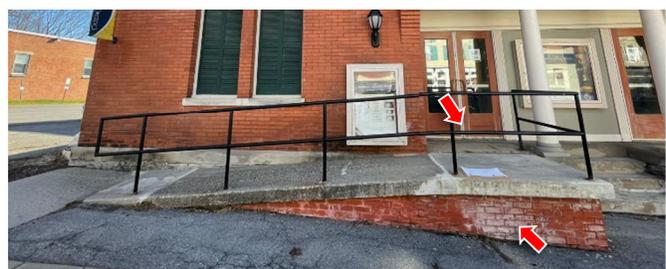
The adjacent accessible ramp, constructed of brick masonry and concrete, is similarly deteriorating. The ramp surface shows visible aggregate due to concrete deterioration. The painted pipe guardrail on the ramp does not meet current accessibility standards, lacking required balusters and handrail extensions. A continuous handrail should also be installed on the opposite side of the ramp to comply with accessibility guidelines.

Deteriorated masonry and concrete at accessible ramp
